MIDLAND RESOLUTION

Parcel 14-15-50-724
Midland Resolution Soil Replacement

Dow Midland Soils Remedy Worksheet

CONSTRUCTION QUALITY ASSURANCE FORM

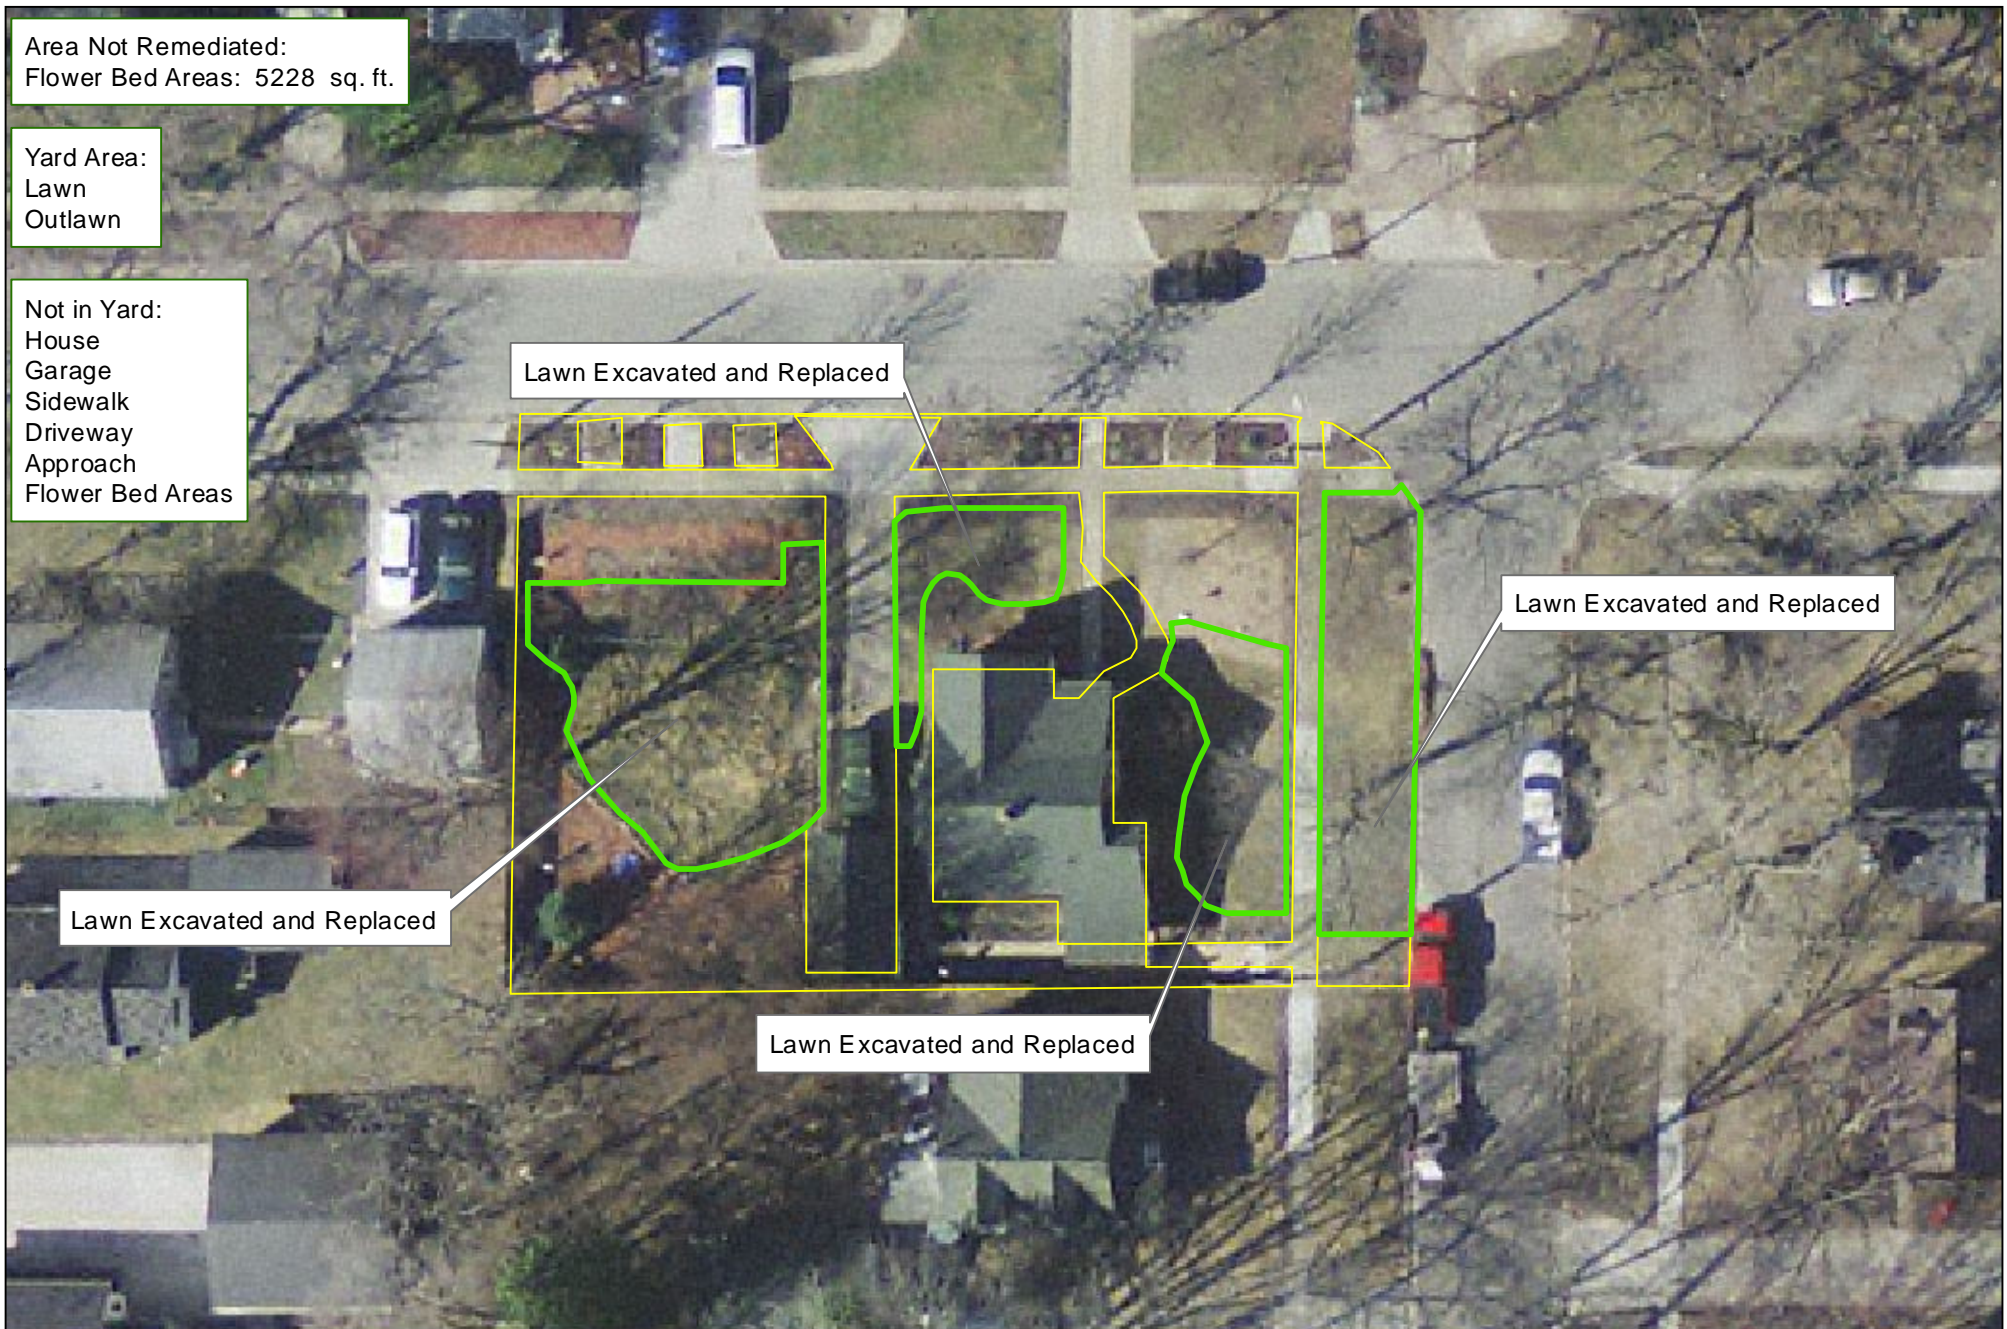
Total Yard Area:
9040 sq. ft.

Area Excavated:
3812 sq. ft.

Total Area Not Excavated:
5228 sq. ft.

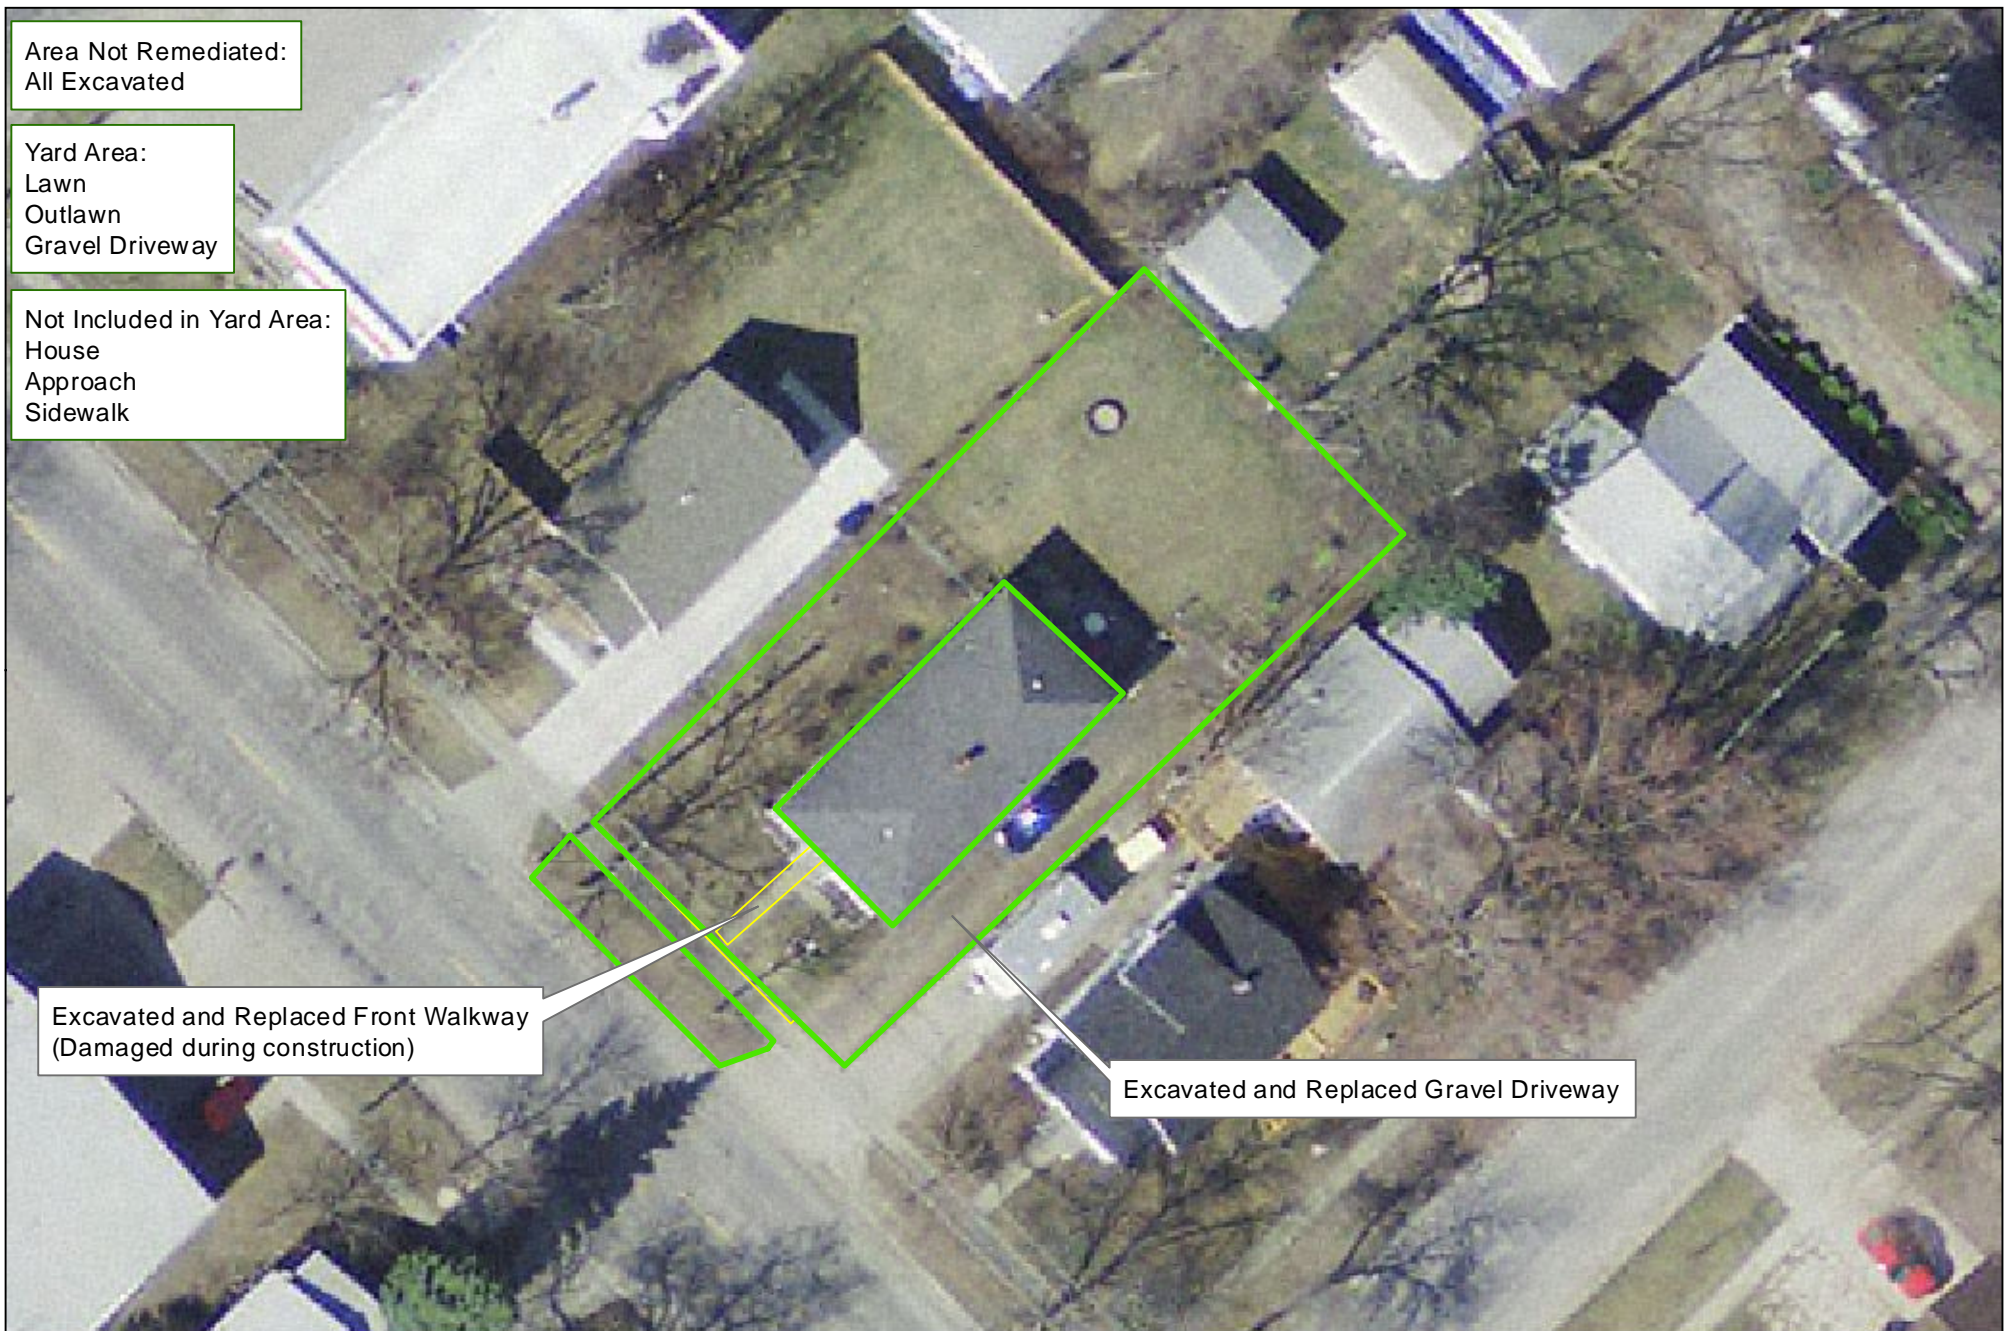
Parcel 14-16-40-140
Midland Resolution Soil Replacement

Area Not Remediated:
All Excavated

Yard Area:
Lawn
Outlawn
Gravel Driveway

Excavated and Replaced Front Walkway
(Damaged during construction)

Excavated and Replaced Gravel Driveway

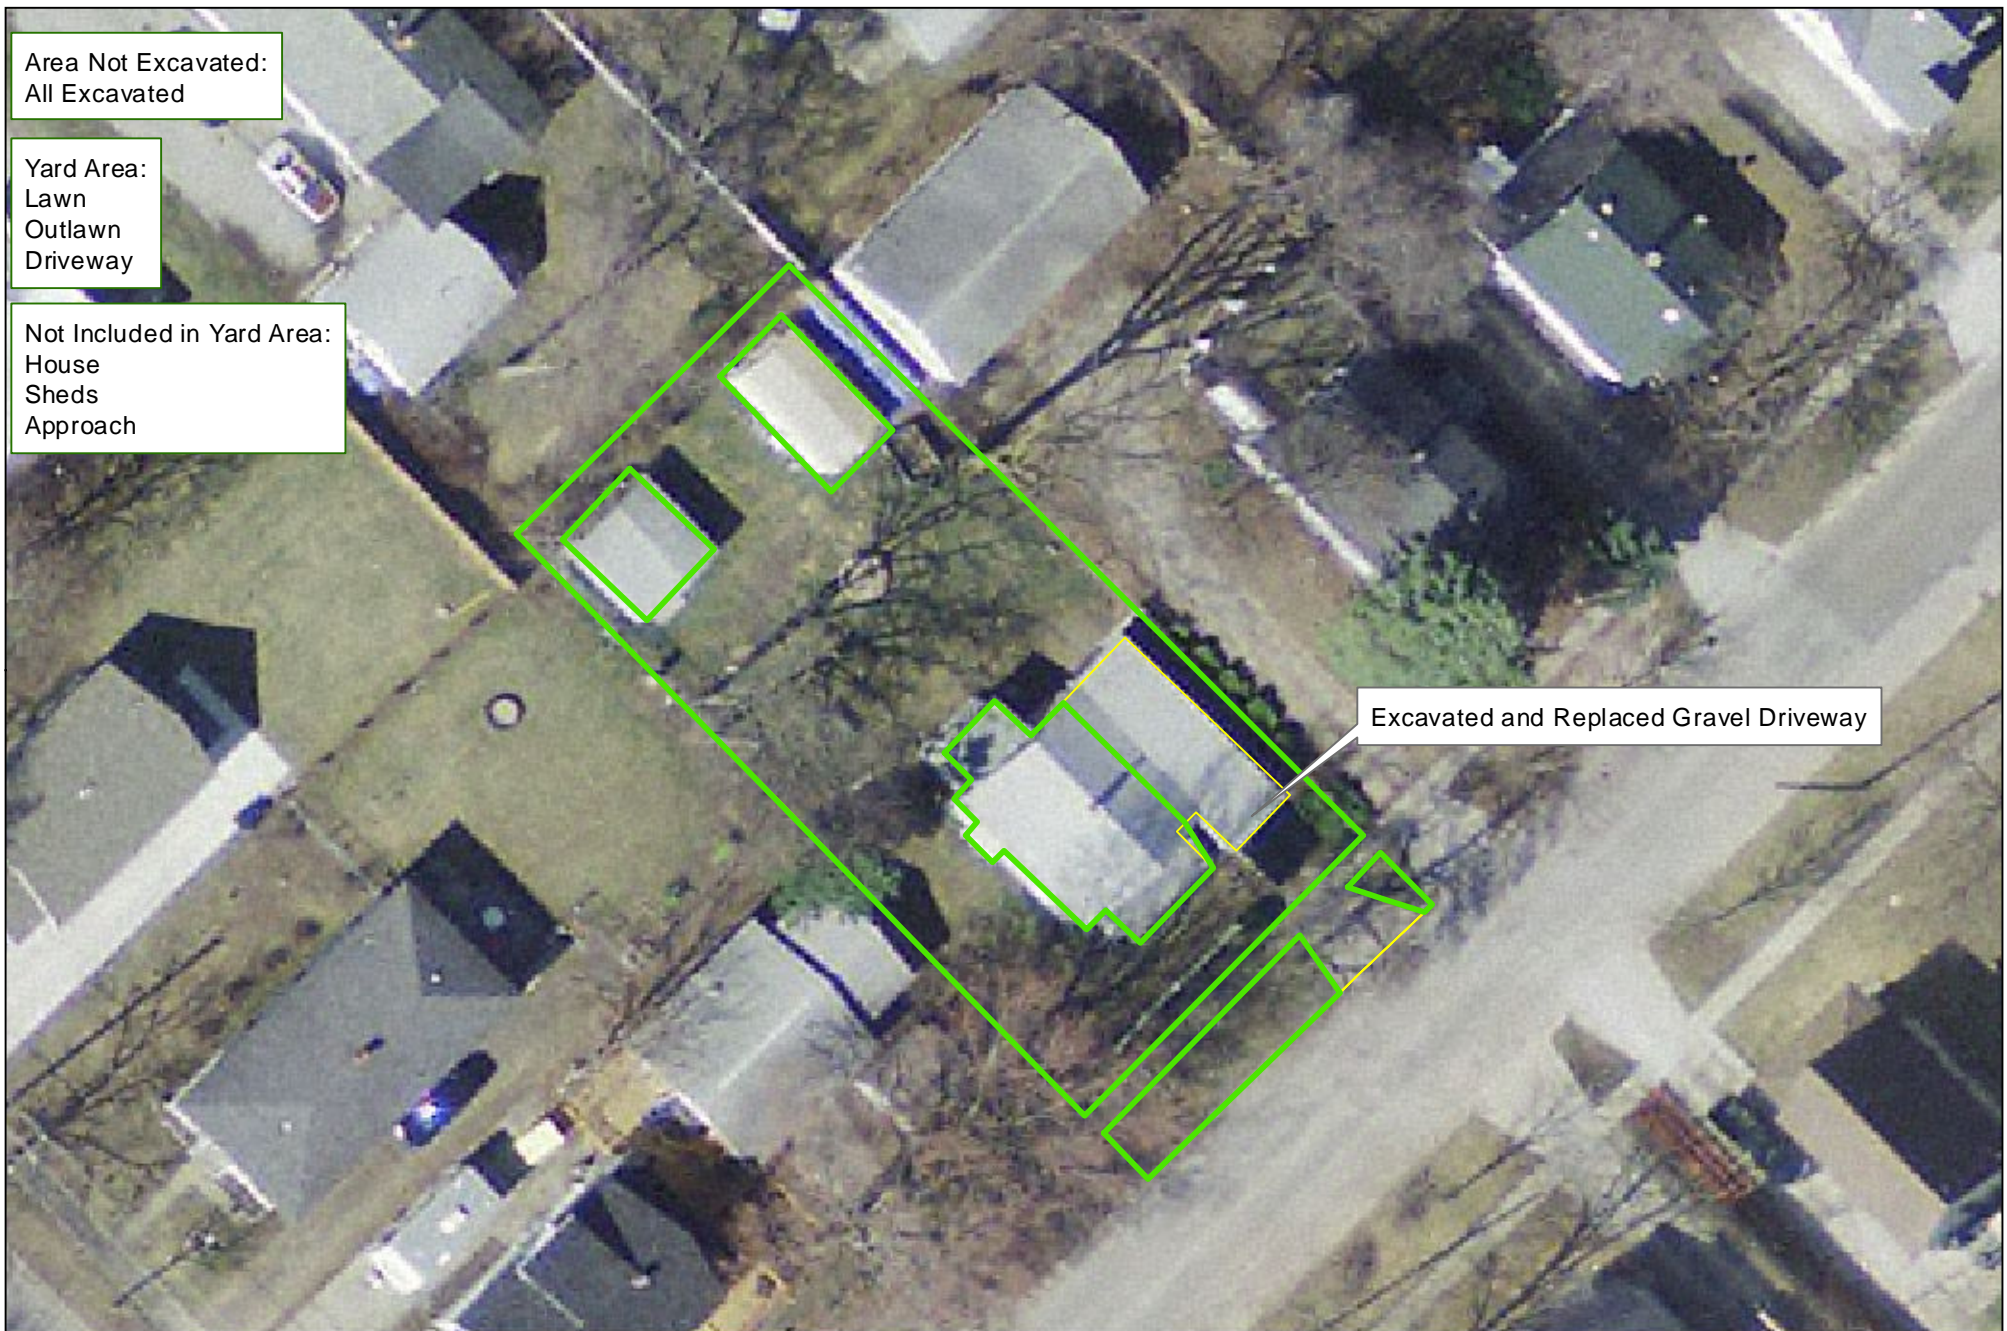
Parcel 14-16-40-144
Midland Resolution Soil Replacement

Area Not Excavated:
All Excavated

Yard Area:
Lawn
Outlawn
Driveway

Excavated and Replaced Gravel Driveway

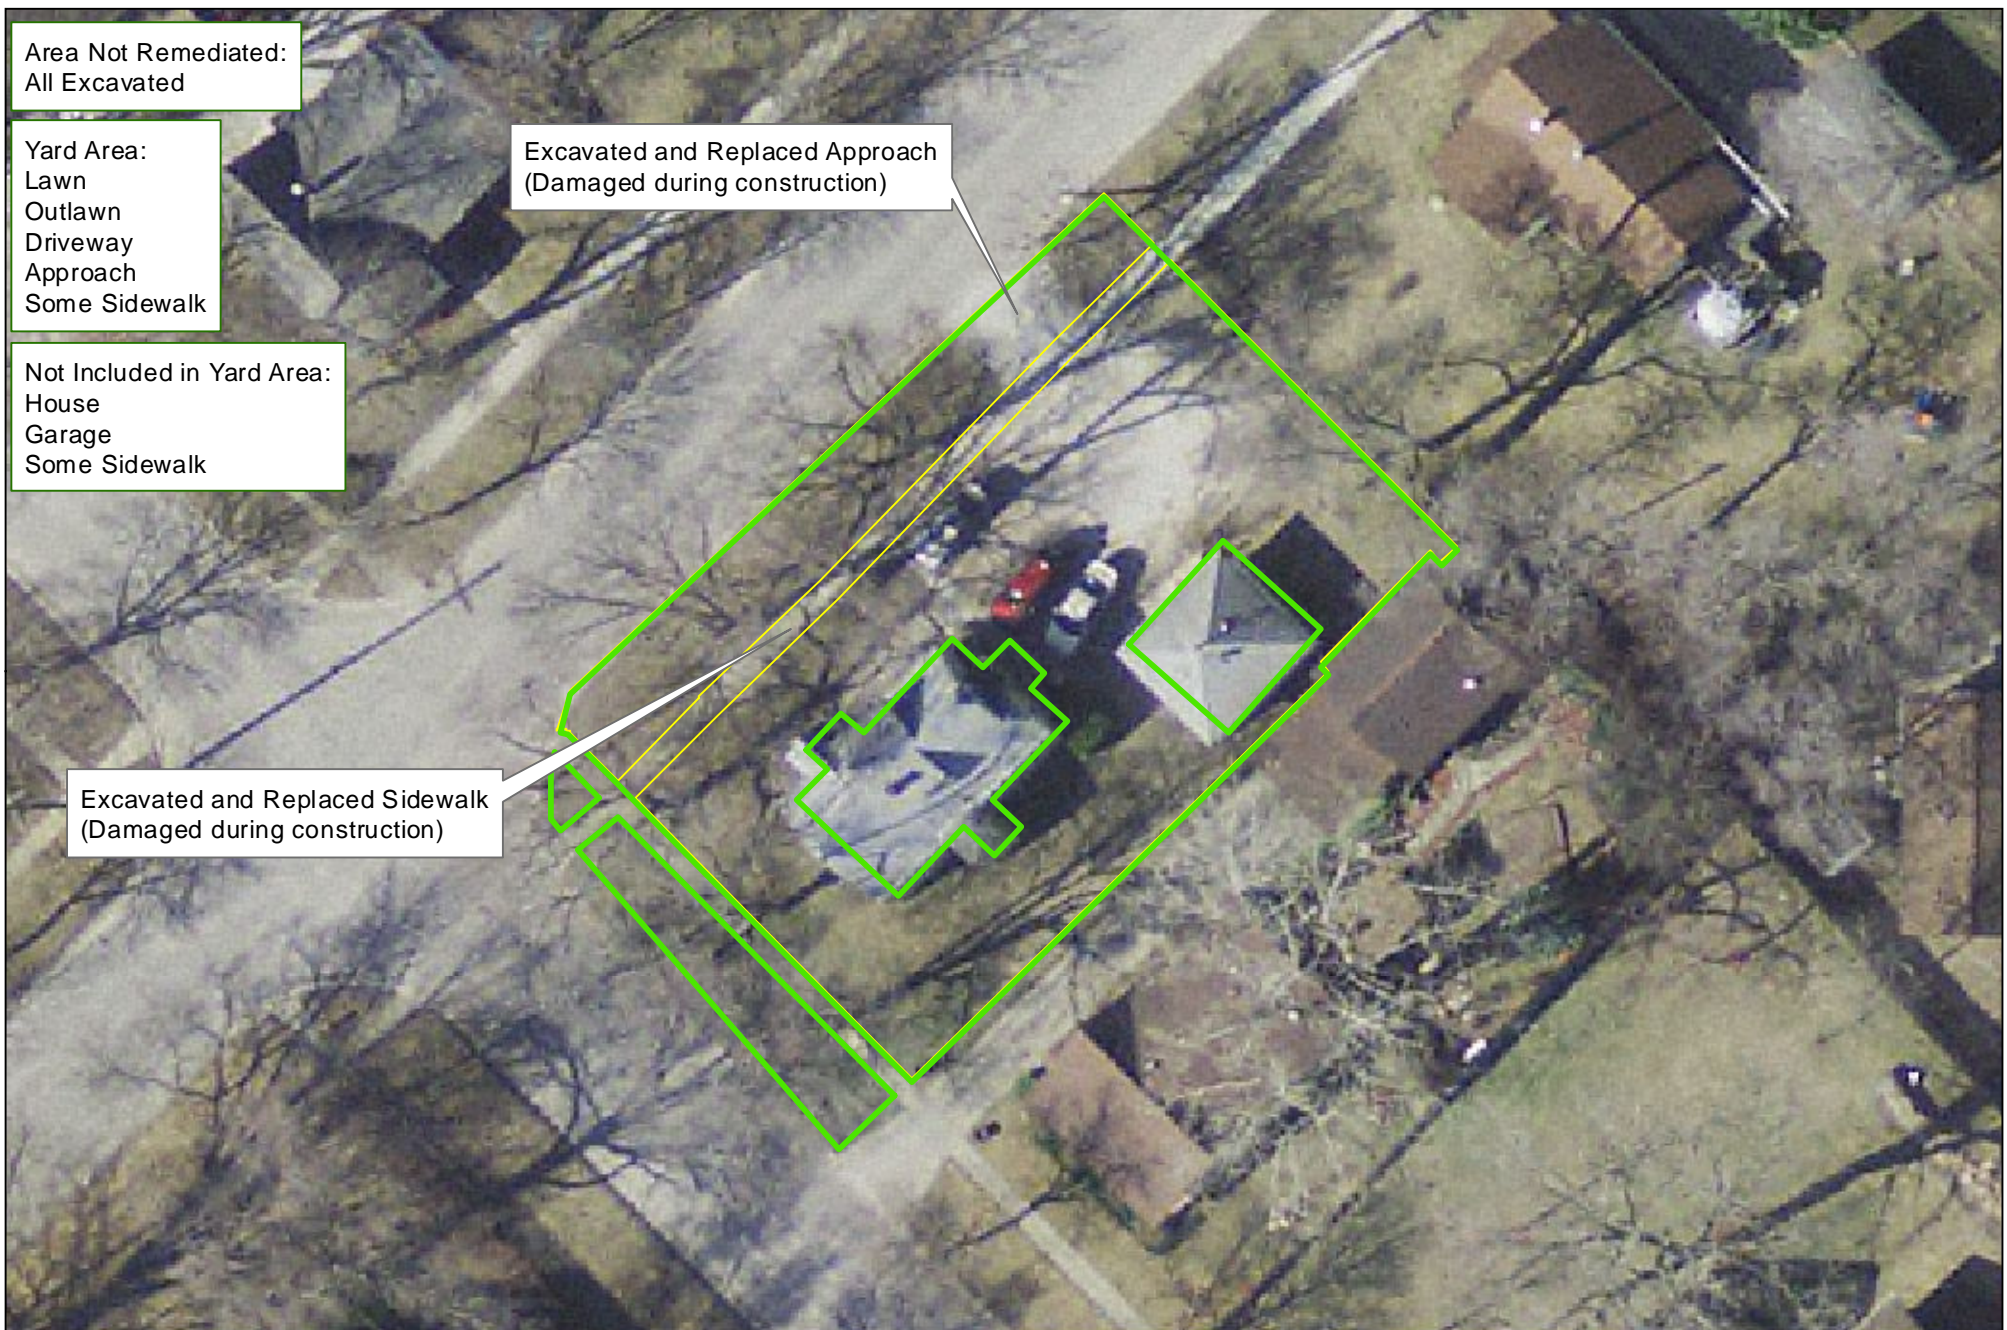
Parcel 14-16-40-048
Midland Resolution Soil Replacement

Area Not Remediated:
All Excavated

Yard Area:
Lawn
Outlawn
Driveway
Approach
Some Sidewalk

Excavated and Replaced Approach
(Damaged during construction)

Excavated and Replaced Sidewalk
(Damaged during construction)
