MIDLAND RESOLUTION

Parcel 14-16-50-246
Midland Resolution Soil Replacement

Dow Midland Soils Remedy Worksheet

CONSTRUCTION QUALITY ASSURANCE FORM

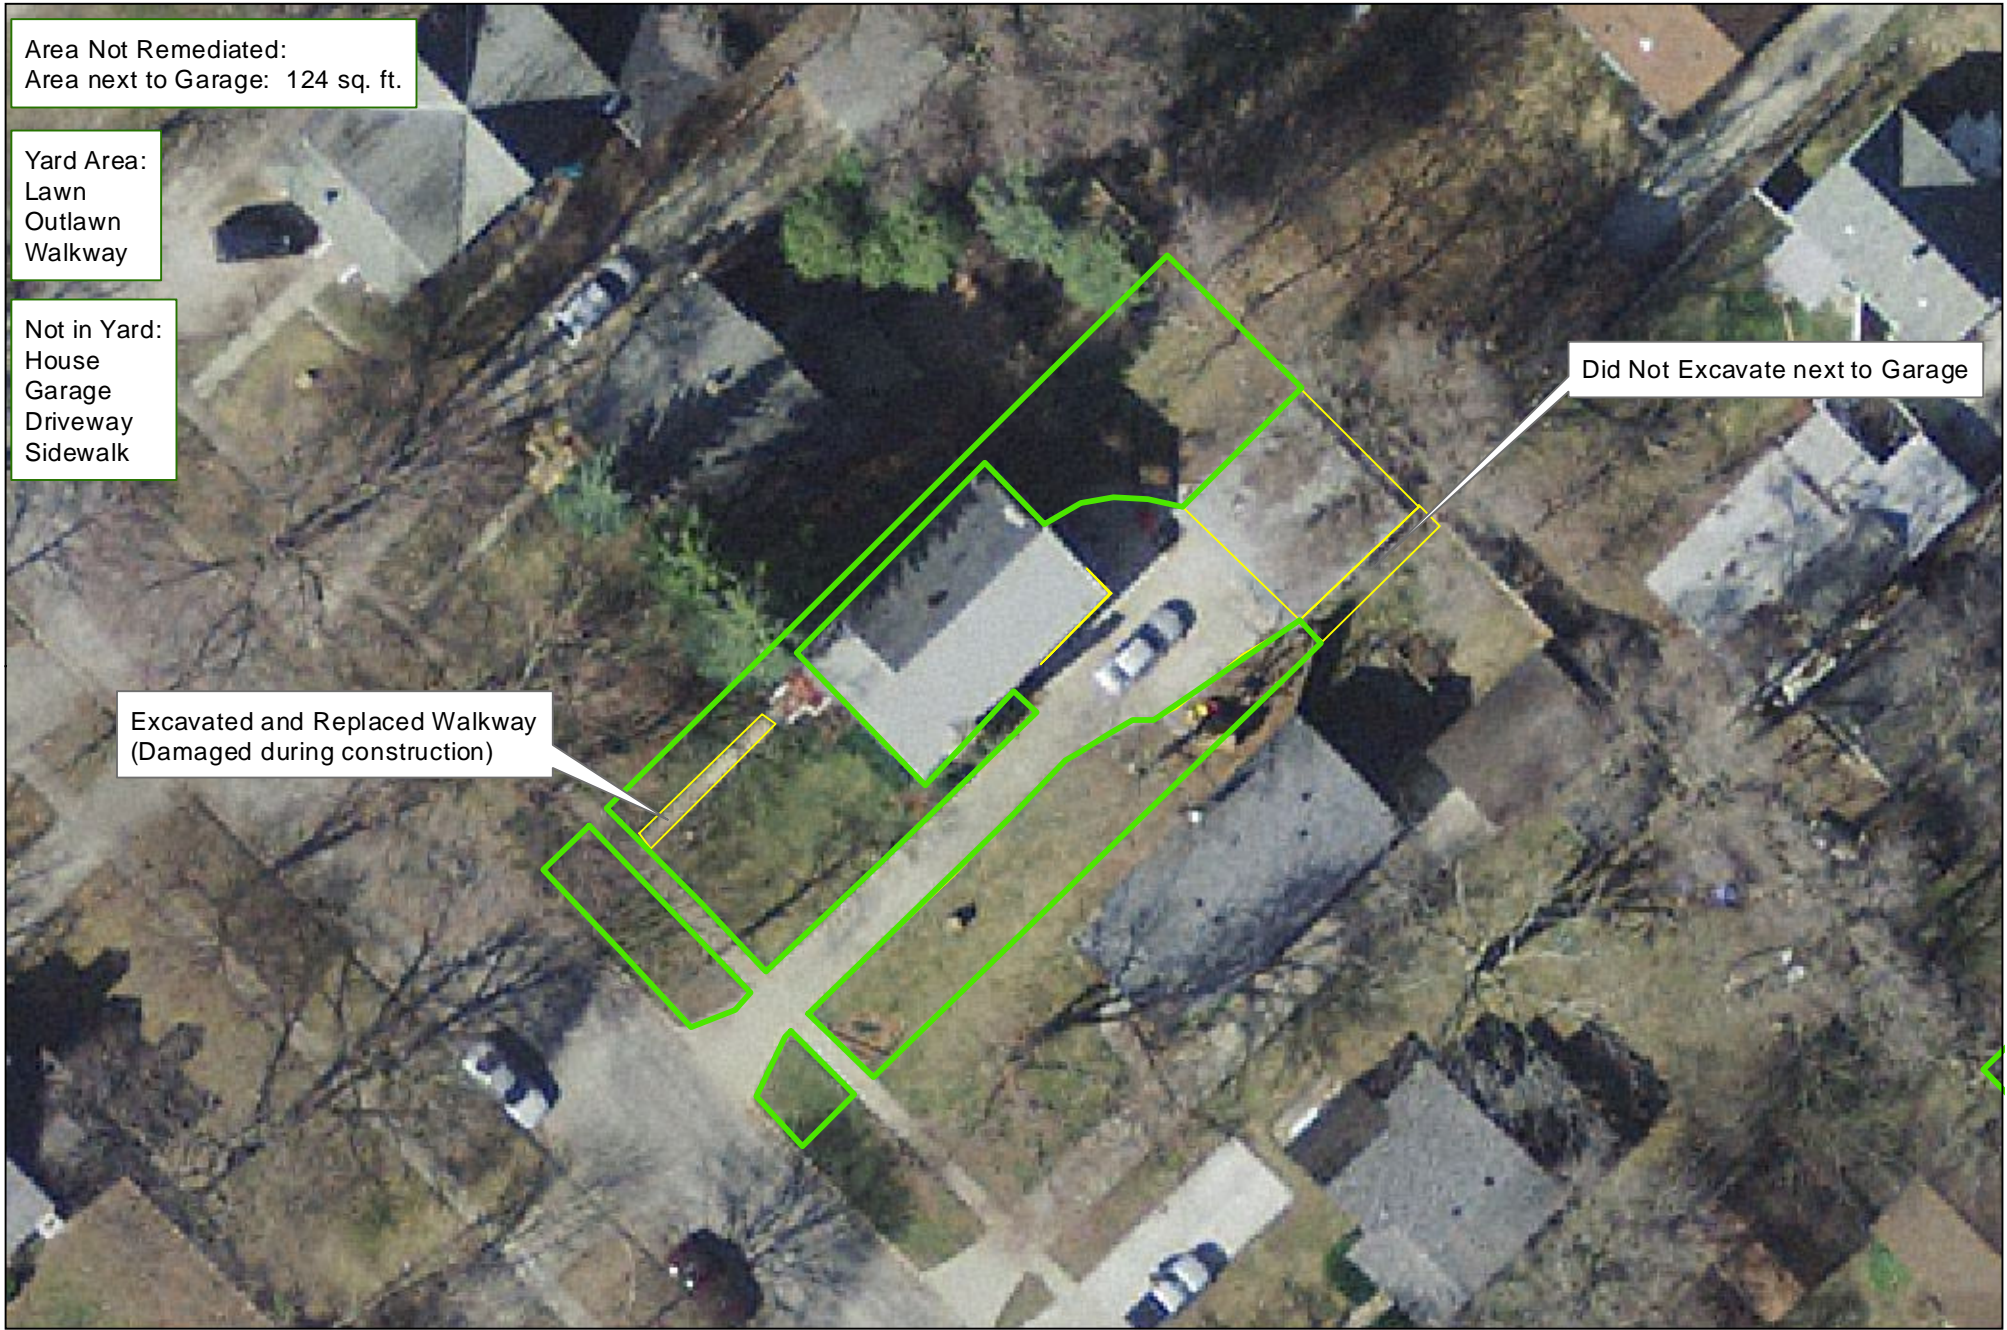
Parcel 14-16-40-418
Midland Resolution Soil Replacement

Total Yard Area: 4644 sq. ft. Area Excavated: 4520 sq. ft. Total Area Not Excavated: 124 sq. ft.

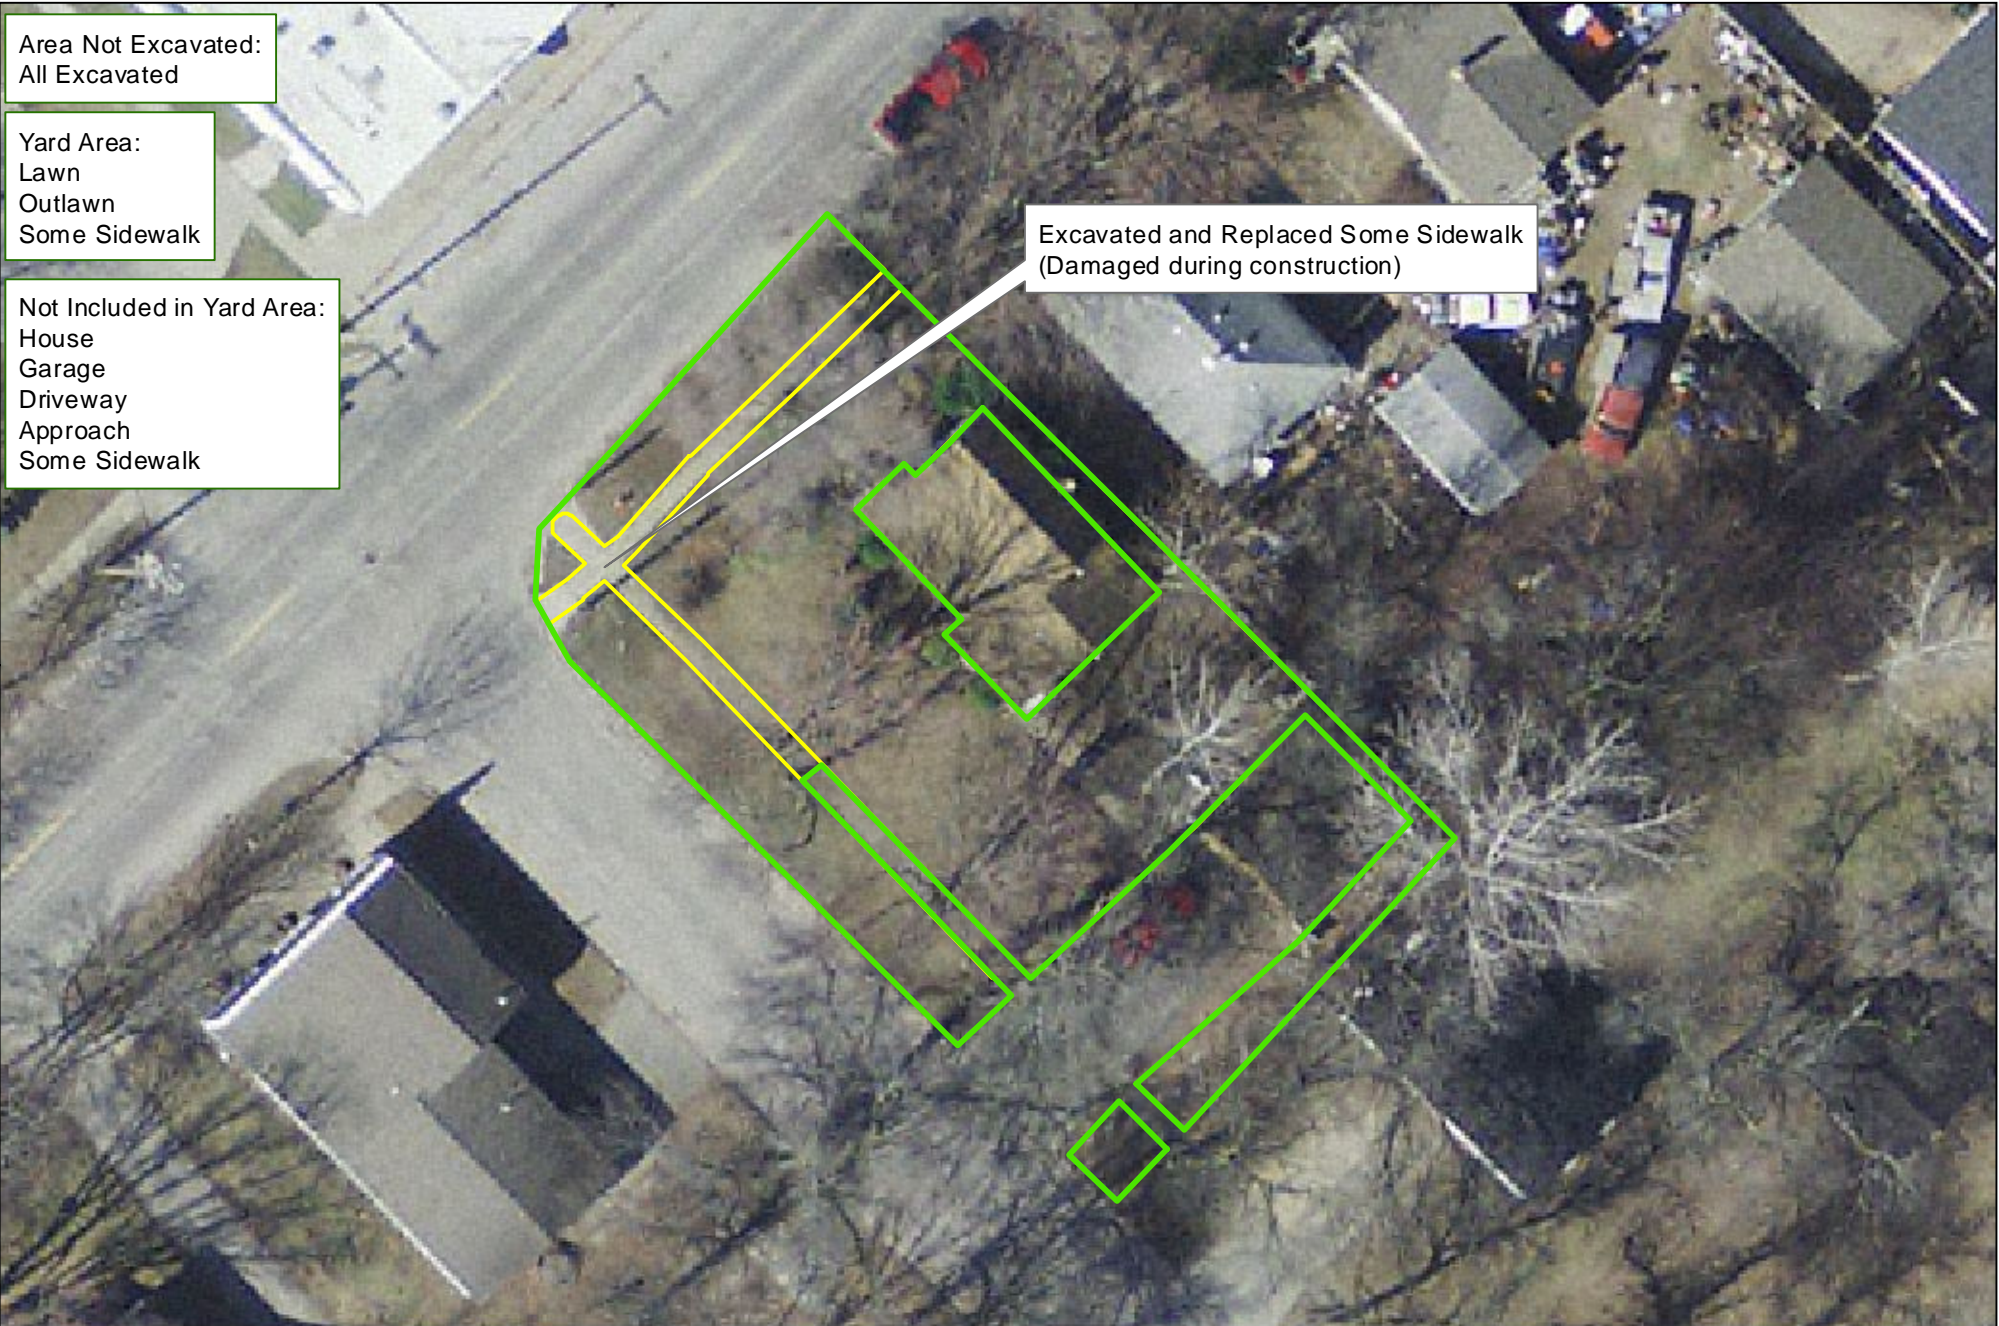
Area Not Excavated:
All Excavated

Yard Area:
Lawn
Outlawn
Some Sidewalk

Excavated and Replaced Some Sidewalk
(Damaged during construction)

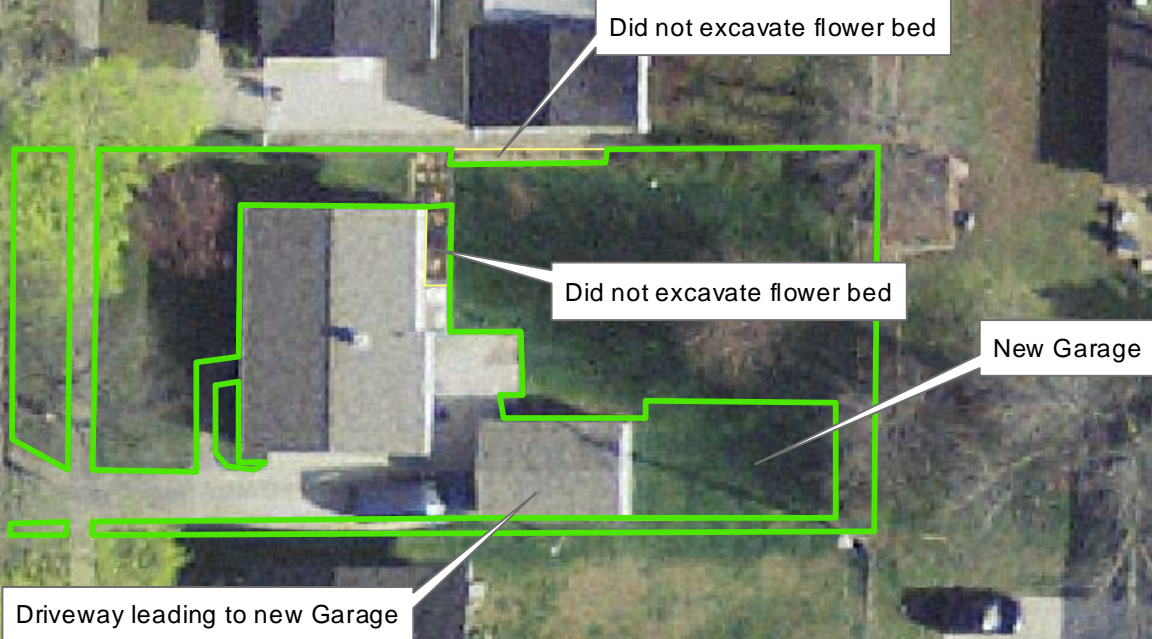
Parcel 14-15-40-016
Midland Resolution Soil Replacement

Total Yard Area: 4732 sq. ft.
Area Excavated: 4630 sq. ft.
Total Area Not Excavated: 102 sq. ft.

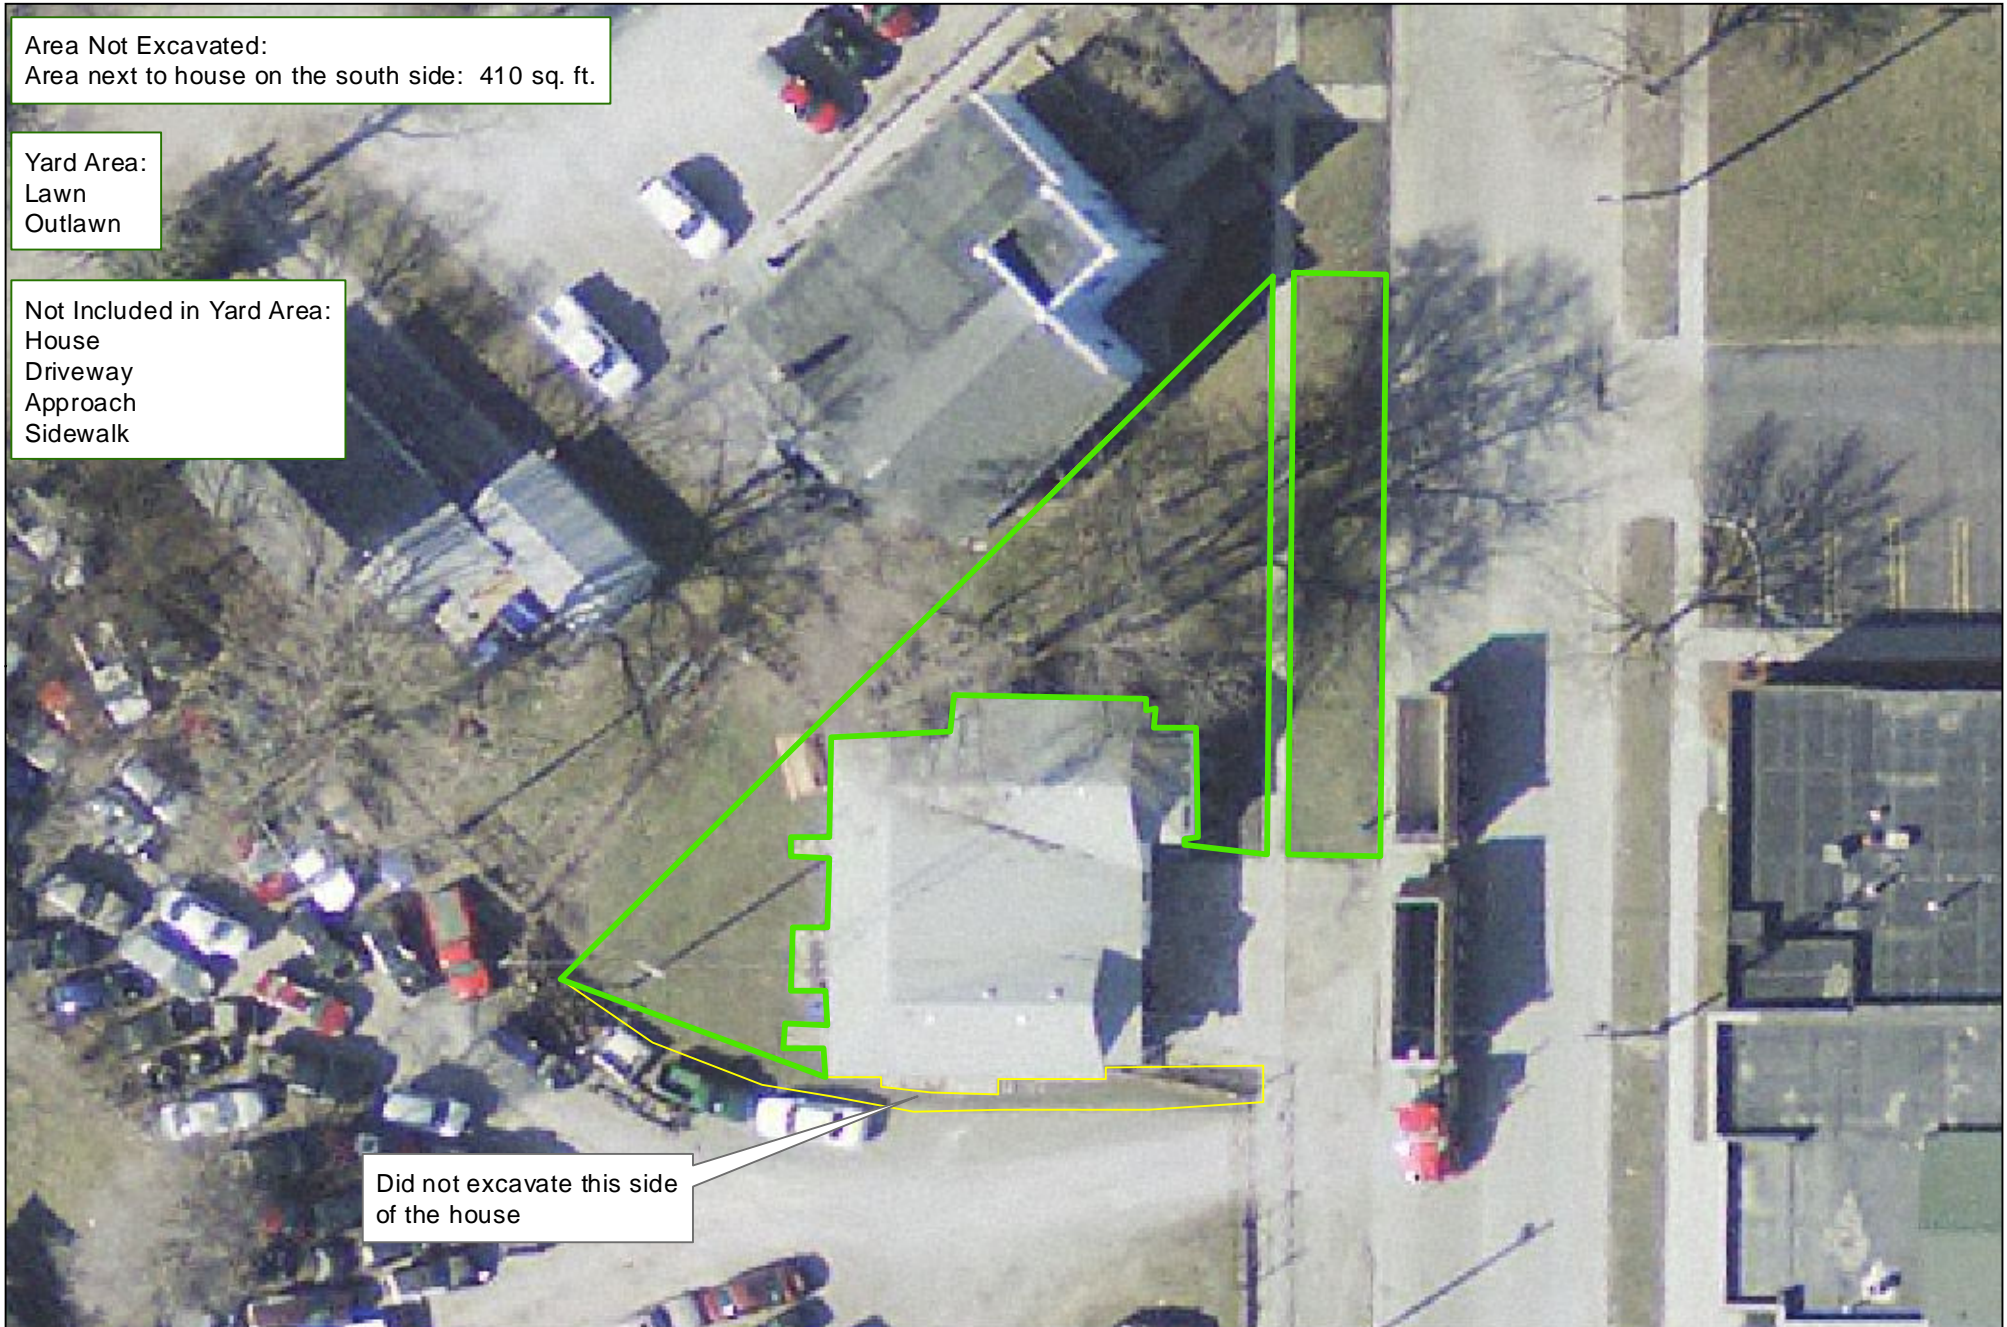
Did not excavate this side
of the house

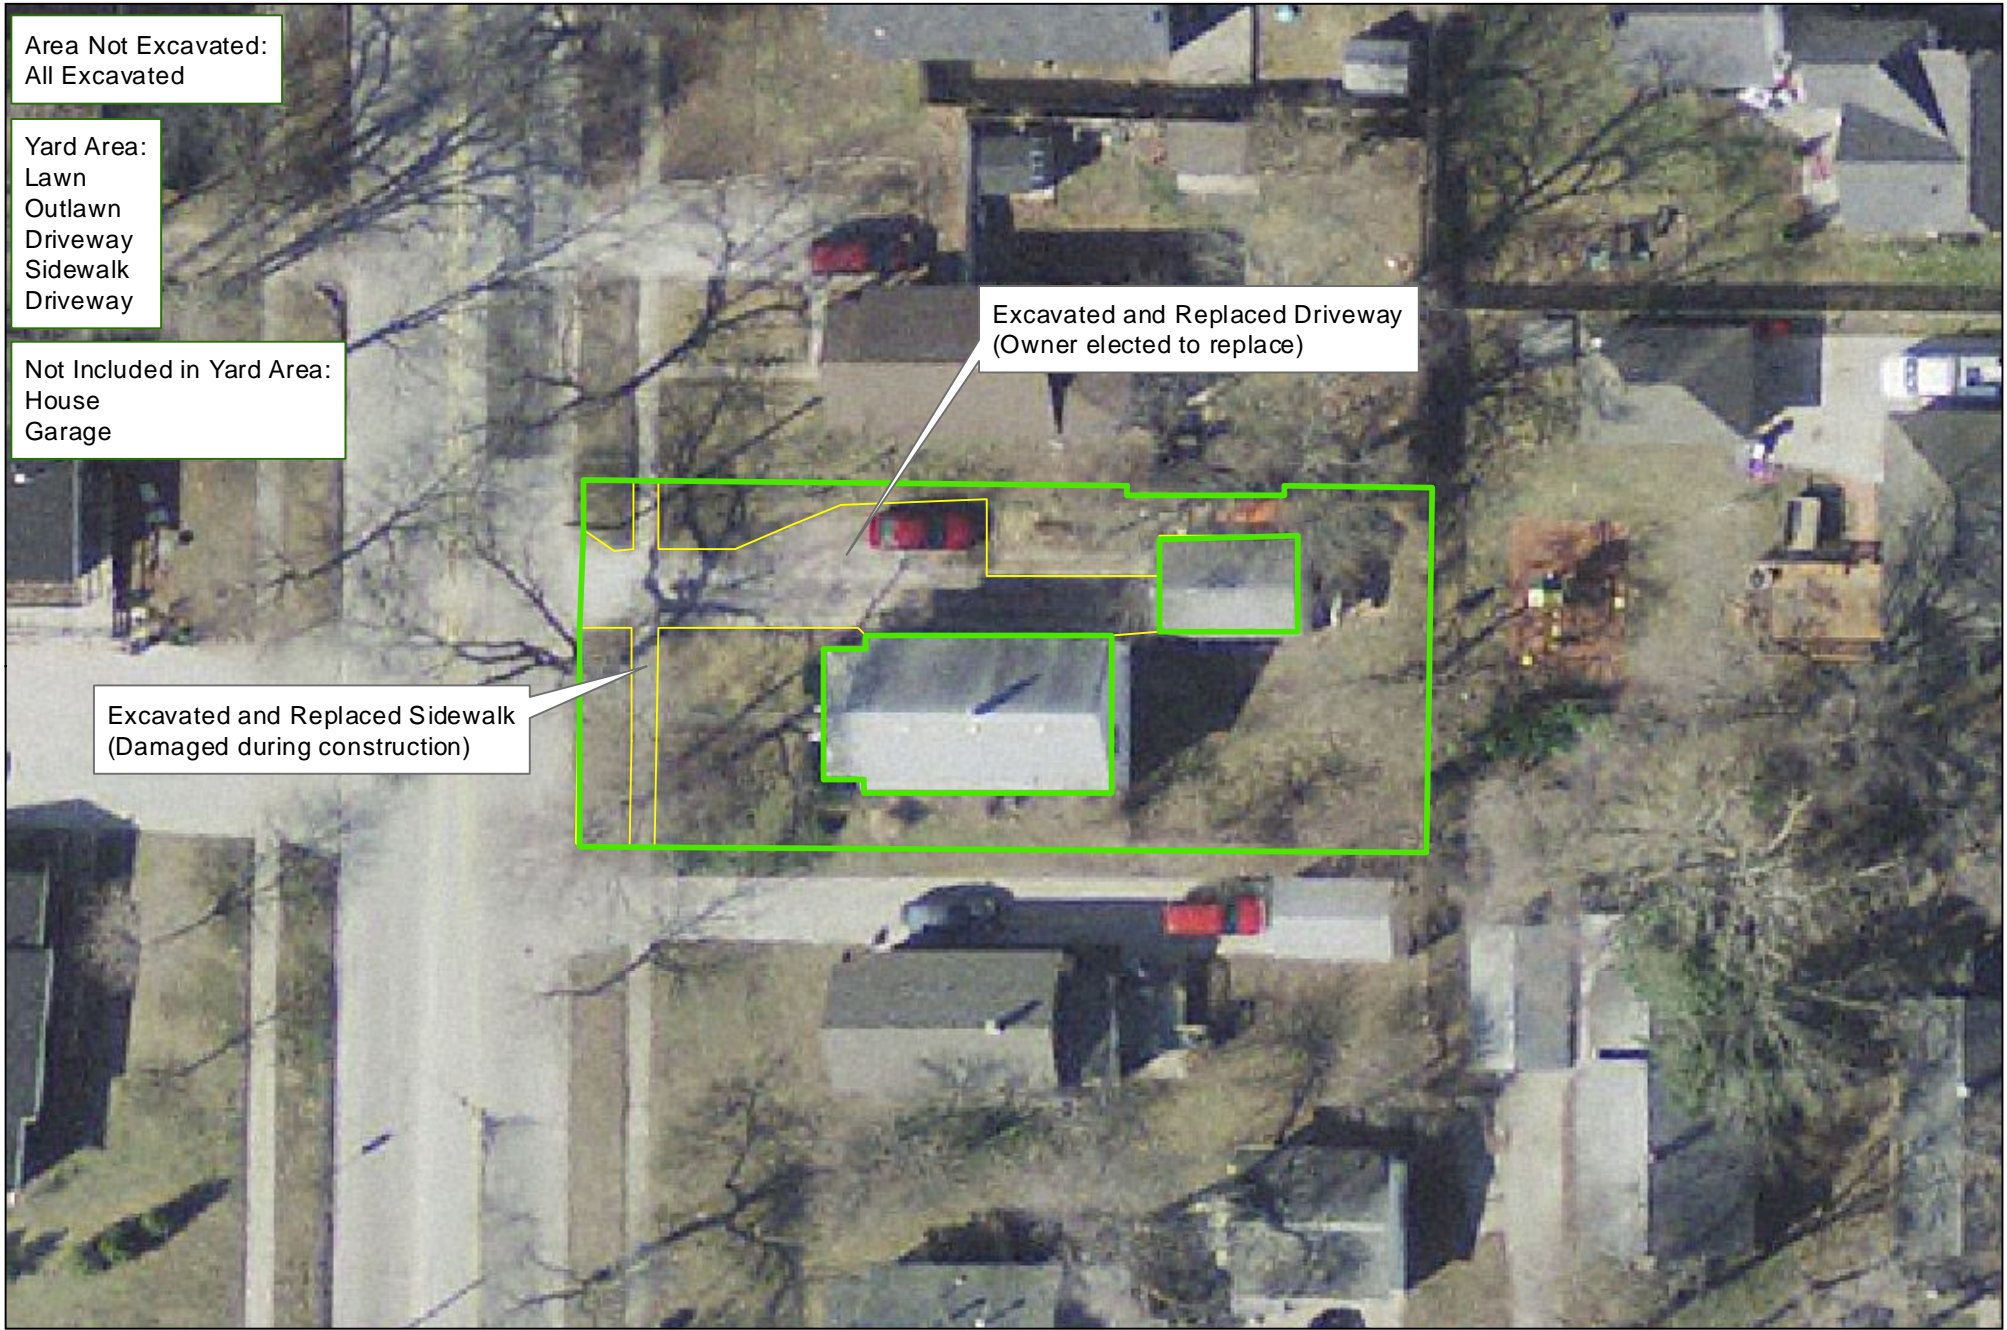
Area Not Excavated:
All Excavated

Yard Area:
Lawn
Outlawn
Driveway
Sidewalk
Driveway

Excavated and Replaced Driveway
(Owner elected to replace)

Excavated and Replaced Sidewalk
(Damaged during construction)

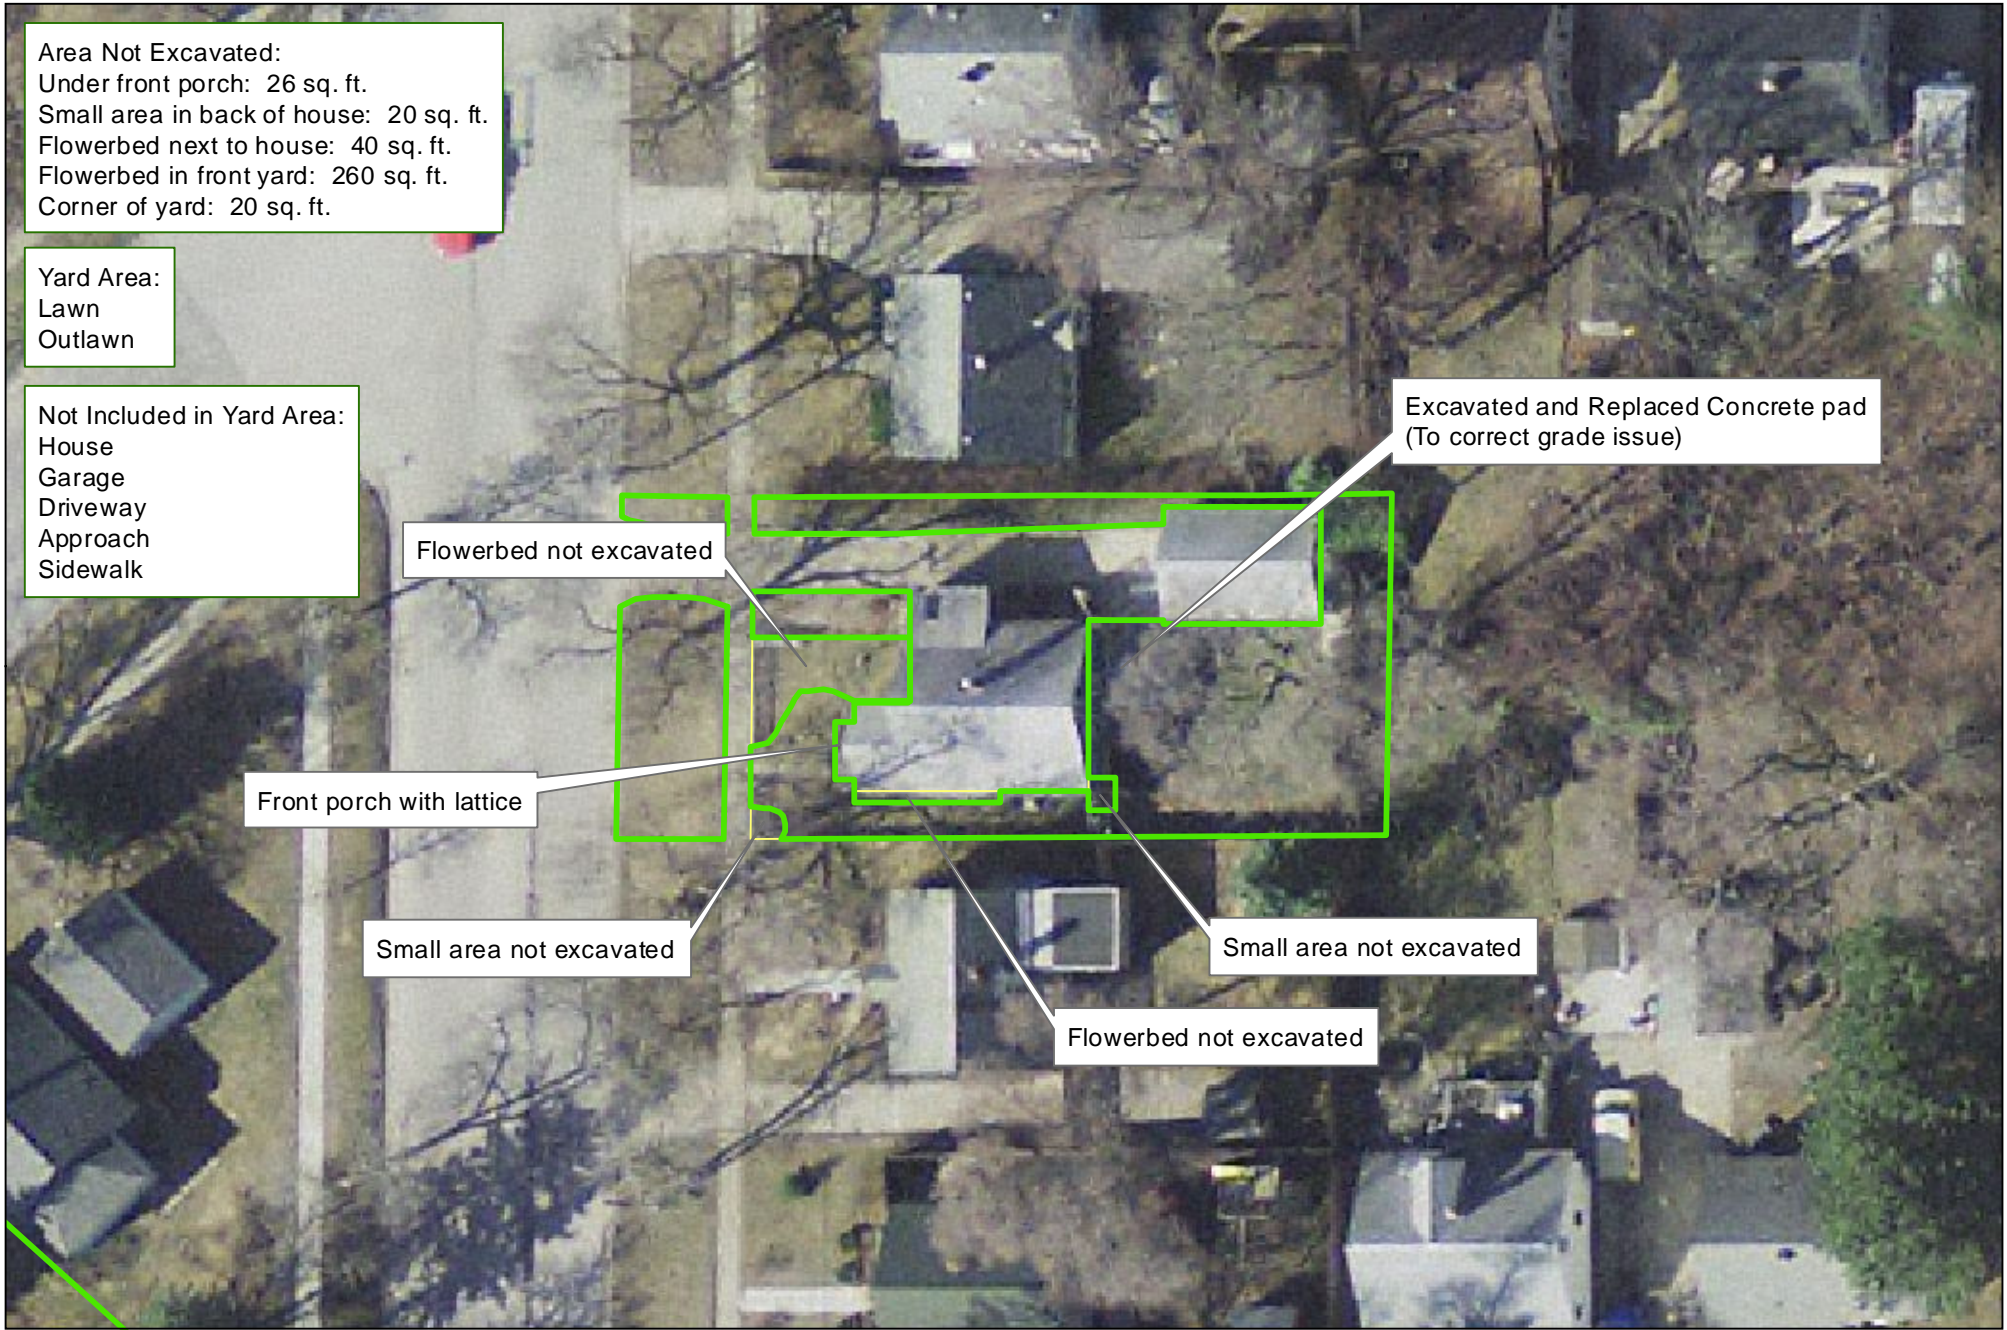
Area Not Excavated:
 Under front porch: 26 sq. ft.
 Small area in back of house: 20 sq. ft.
 Flowerbed next to house: 40 sq. ft.
 Flowerbed in front yard: 260 sq. ft.
 Corner of yard: 20 sq. ft.

Yard Area:
 Lawn
 Outlawn

Excavated and Replaced Concrete pad
 (To correct grade issue)

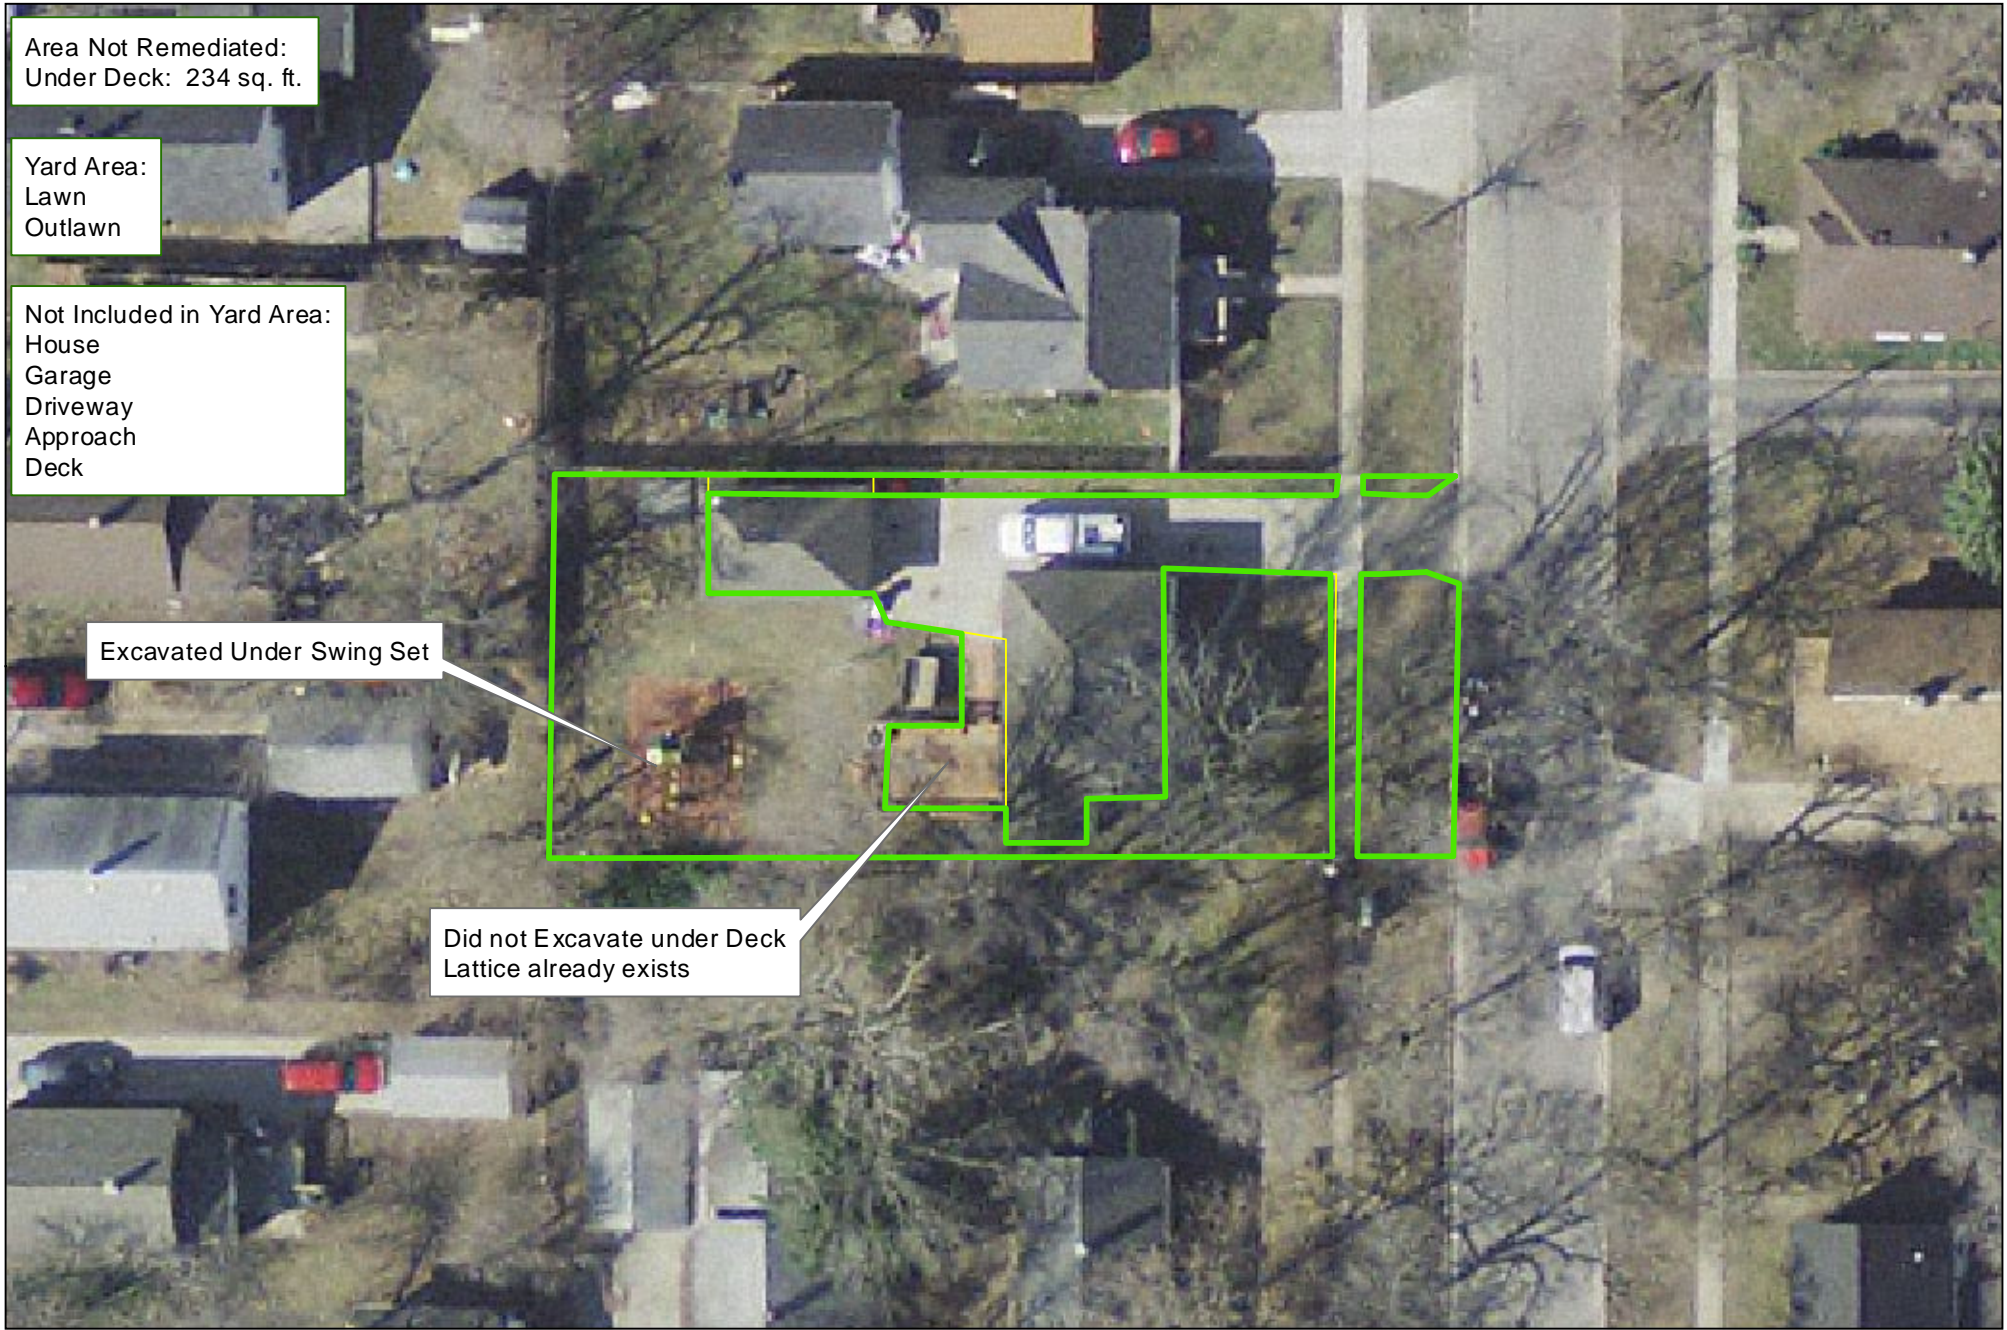
Area Not Remediated:
Under Deck: 234 sq. ft.

Yard Area:
Lawn
Outlawn
