MIDLAND RESOLUTION

Parcel 14-15-50-624  
Midland Resolution Soil Replacement

## Dow Midland Soils Remedy Worksheet

# CONSTRUCTION QUALITY ASSURANCE FORM

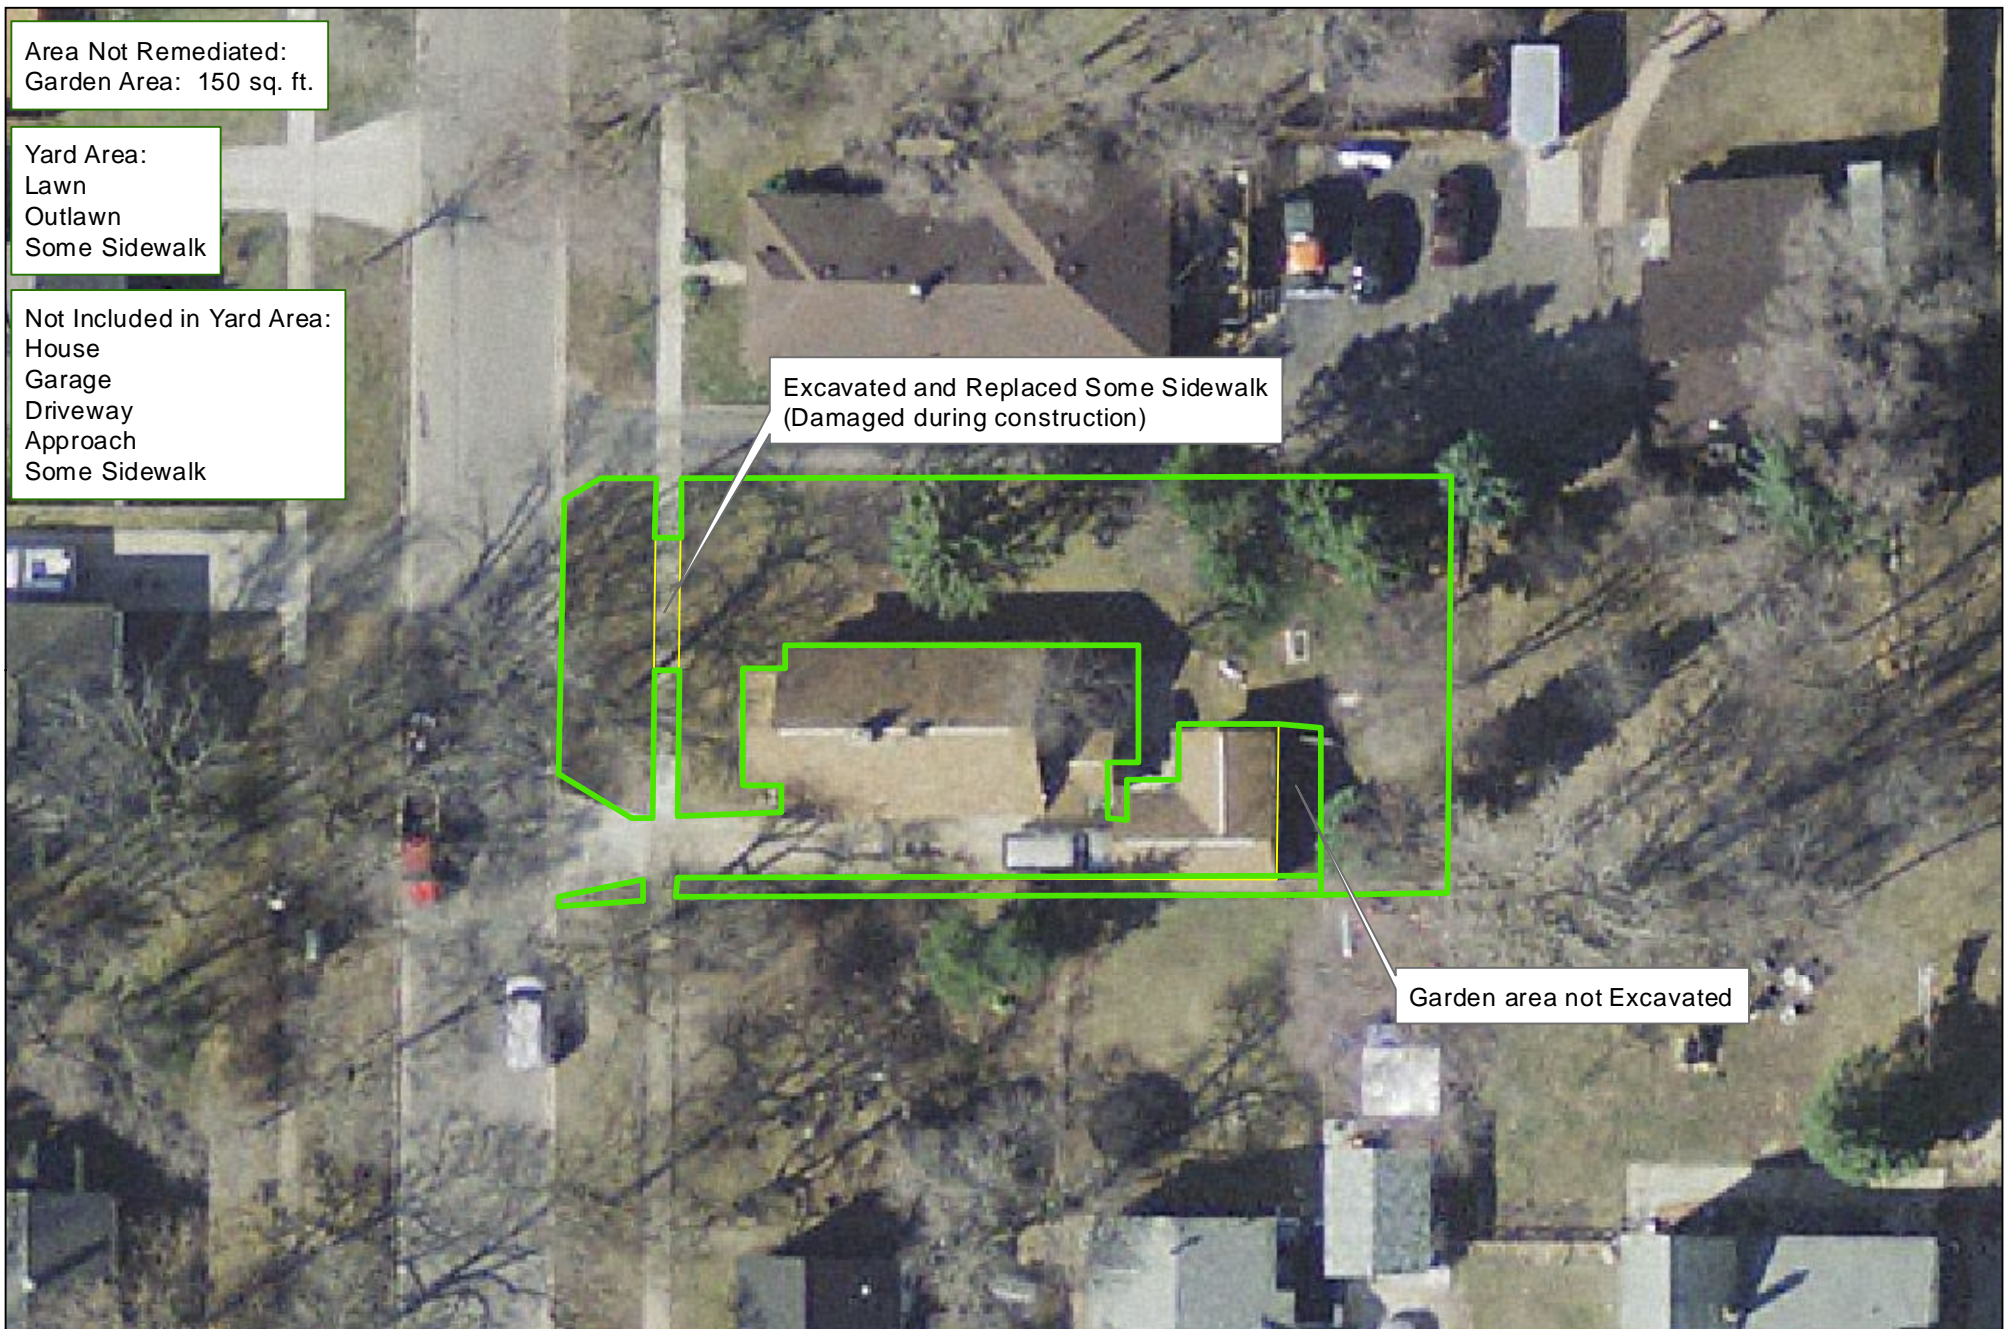
- Remediated Area
- Property

Total Yard Area:  
5949 sq. ft.

Area Excavated:  
5799 sq. ft.

Total Area Not Excavated:  
150 sq. ft.

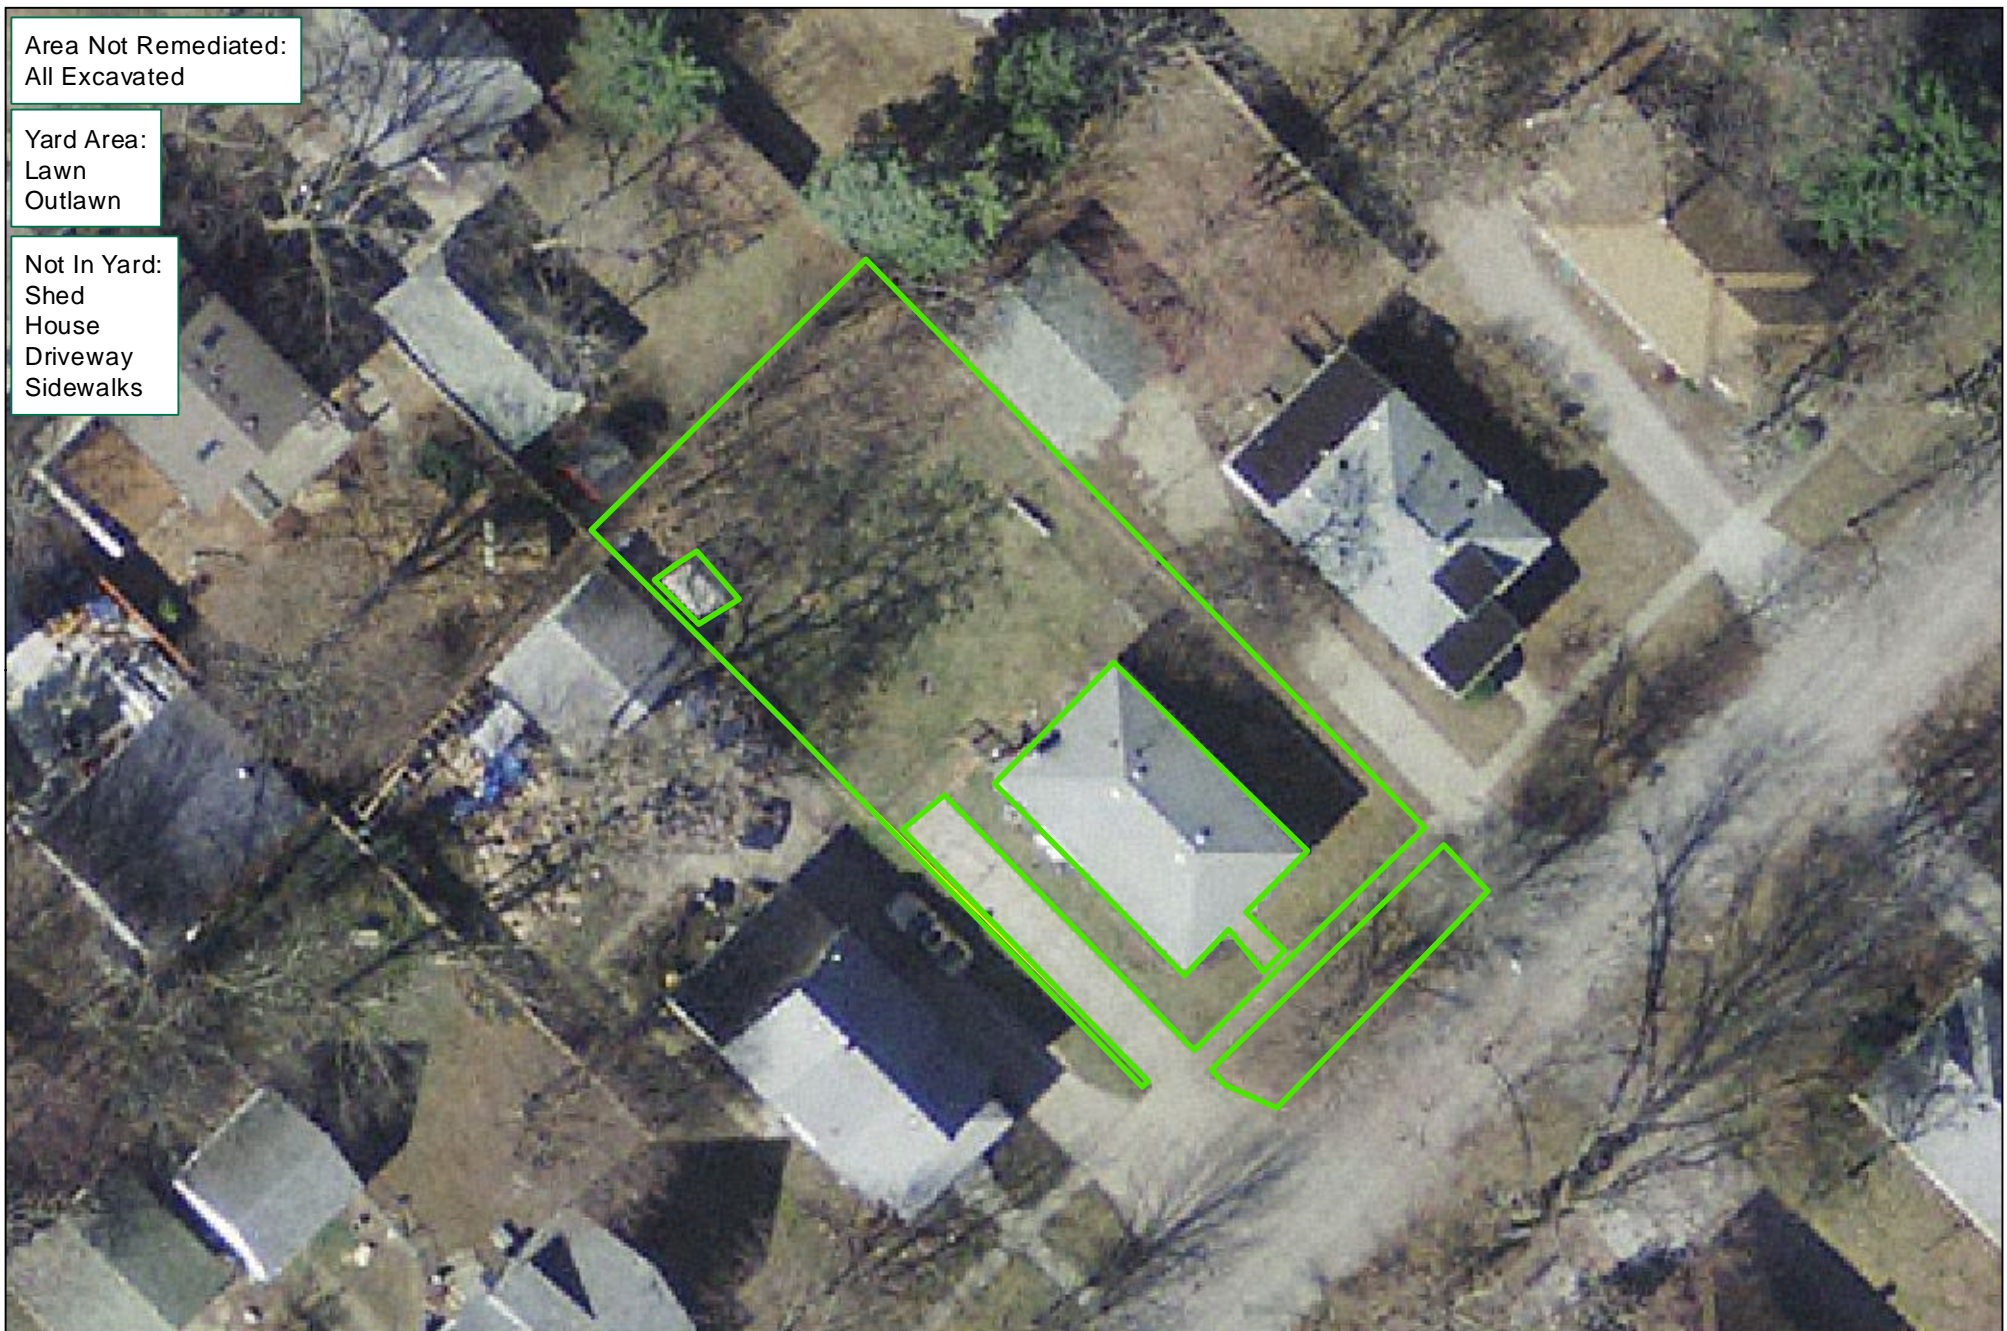
Parcel 14-16-40-584  
Midland Resolution Soil Replacement

Area Not Remediated:  
All Excavated

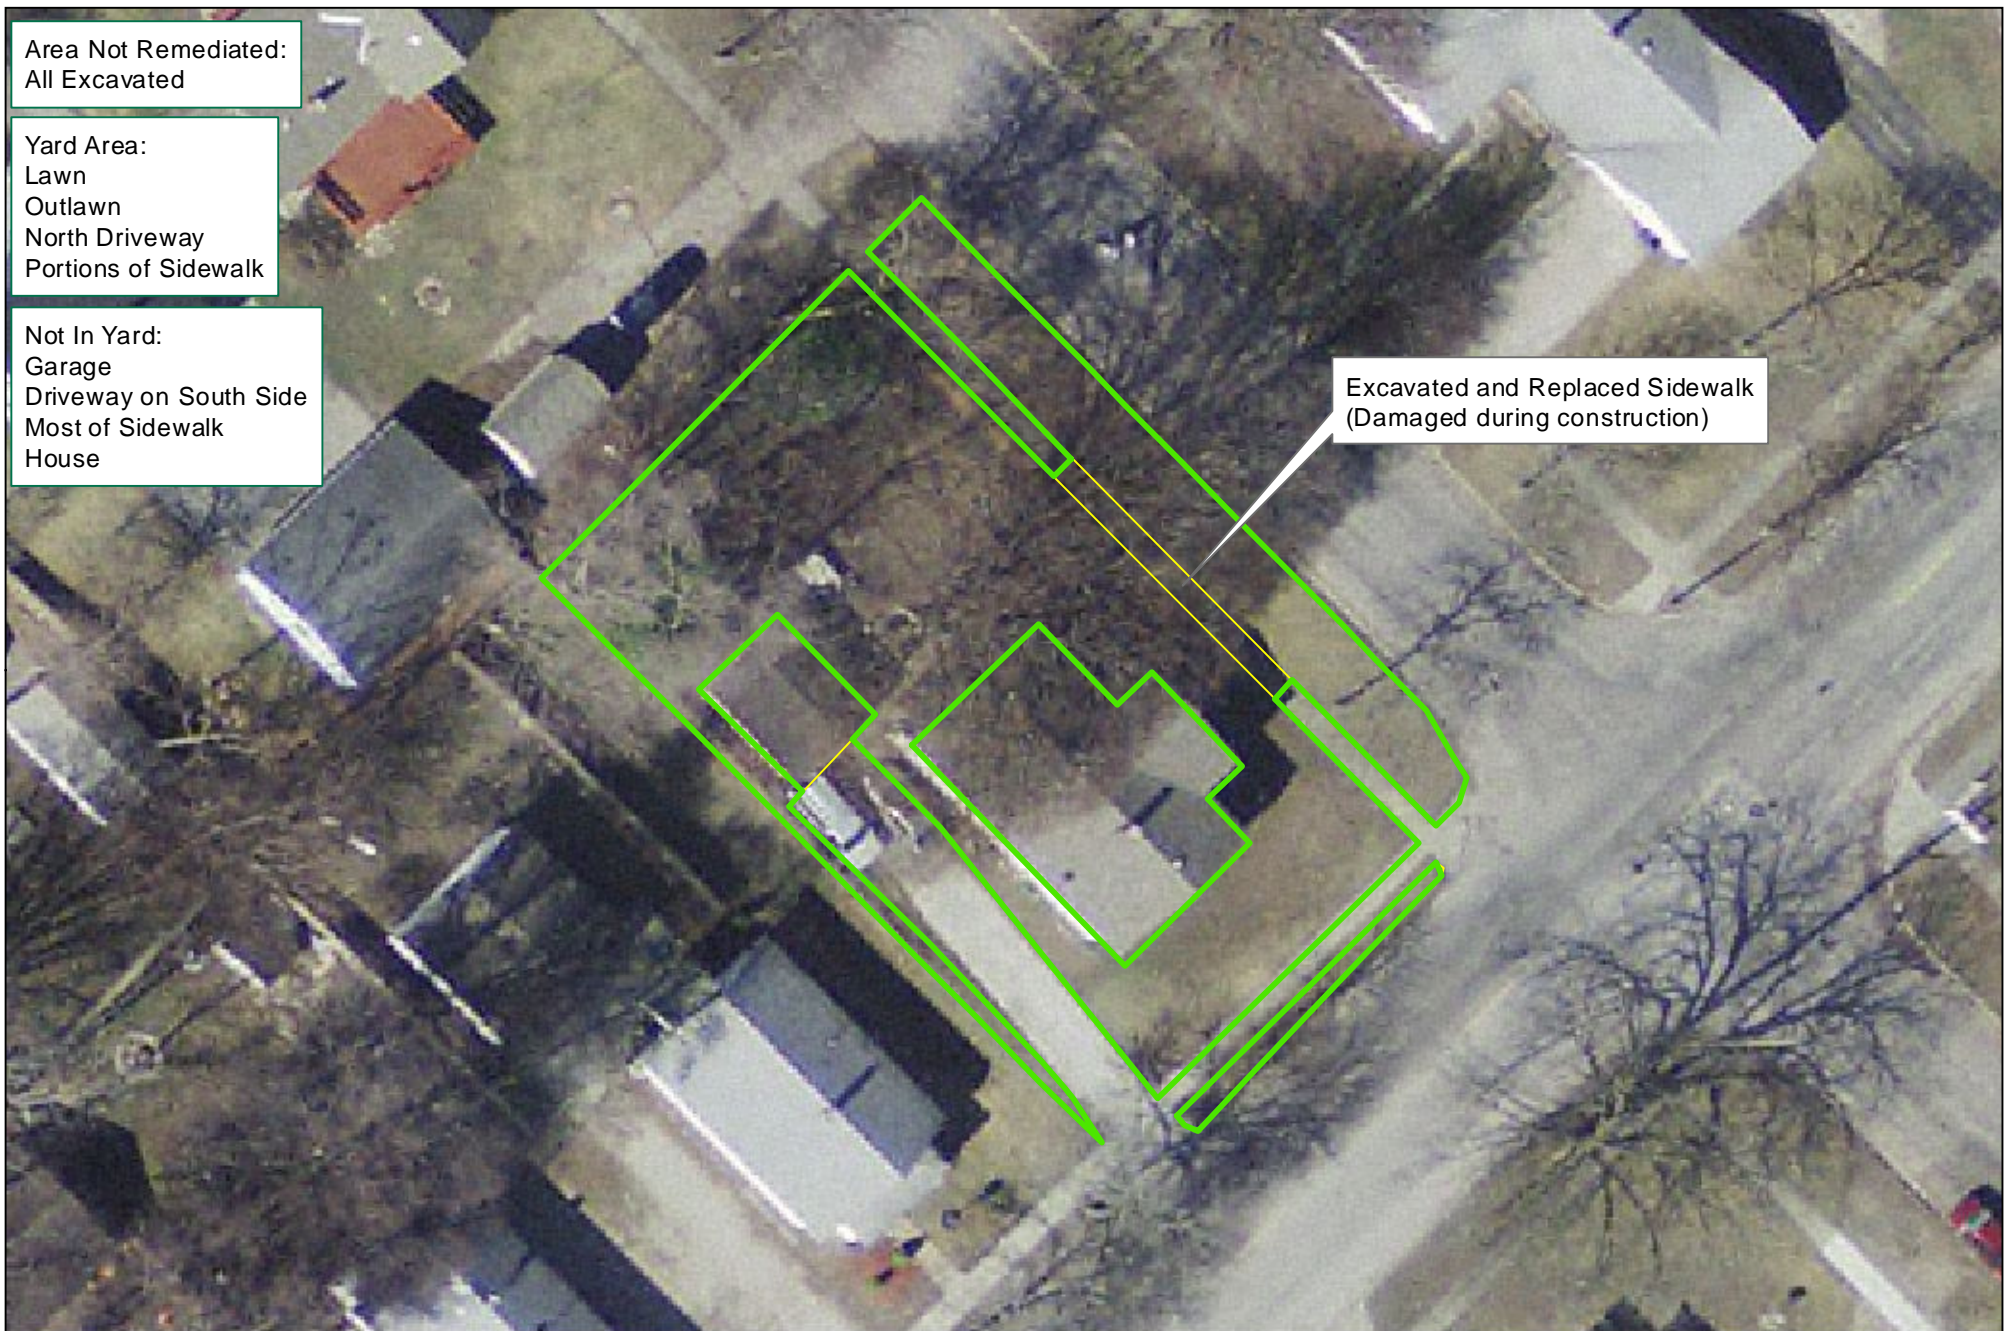
Parcel 14-16-40-194  
Midland Resolution Soil Replacement

Area Not Remediated:  
All Excavated

Excavated and Replaced Sidewalk  
(Damaged during construction)

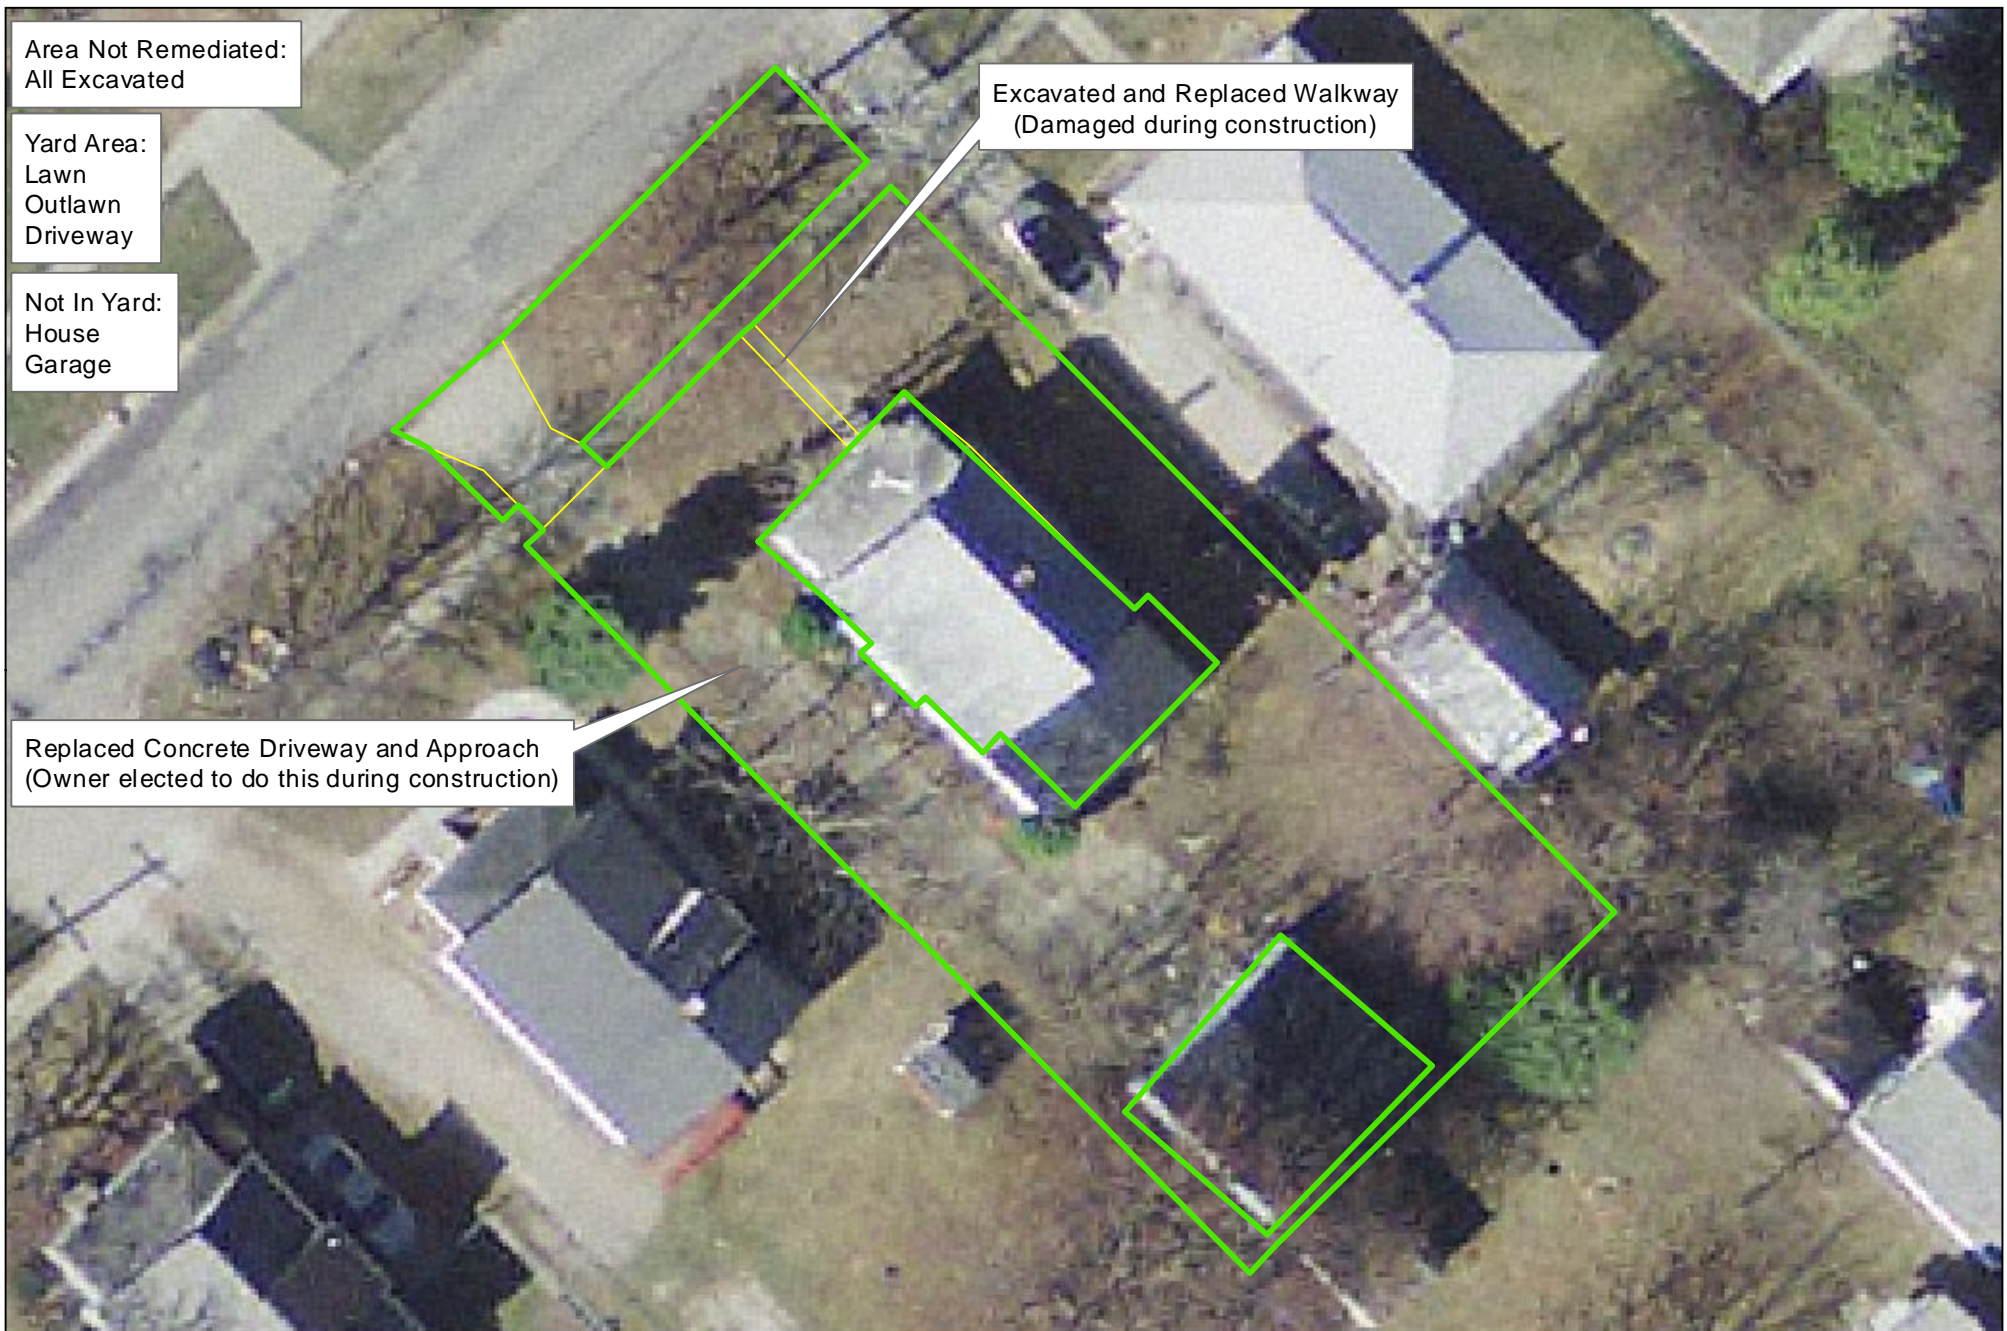
Area Not Remediated:  
All Excavated

Excavated and Replaced Walkway  
(Damaged during construction)

Replaced Concrete Driveway and Approach  
(Owner elected to do this during construction)
