MIDLAND RESOLUTION

Parcel 14-16-30-460
Midland Resolution Soil Replacement

Dow Midland Soils Remedy Worksheet

CONSTRUCTION QUALITY ASSURANCE FORM

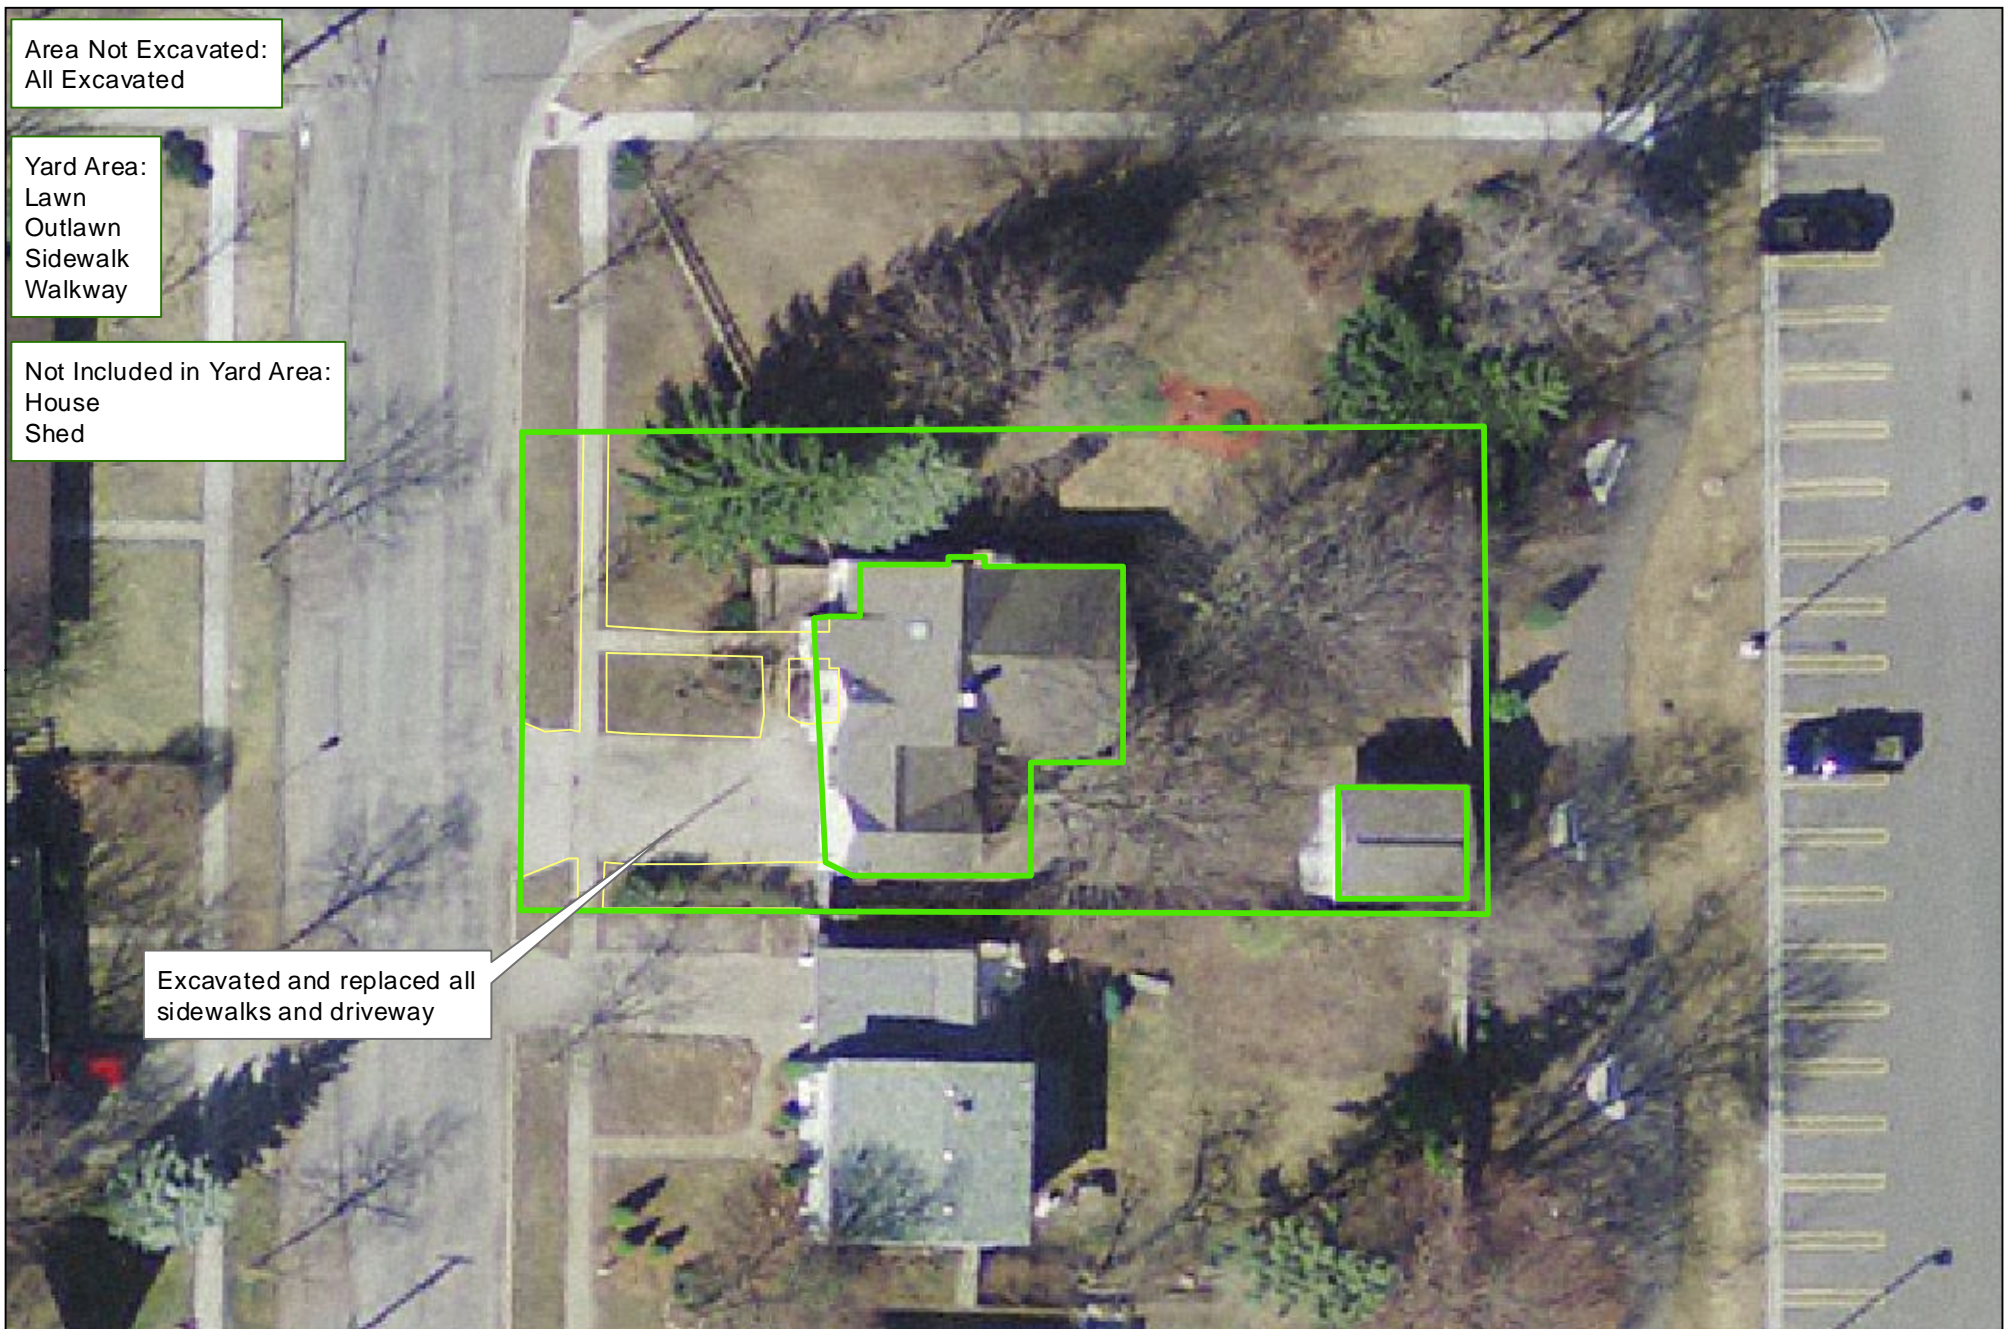
- Remediated Area
- Property

Total Yard Area:
8658 sq. ft.

Area Excavated:
8658 sq. ft.

Total Area Not Excavated:
0 sq. ft.

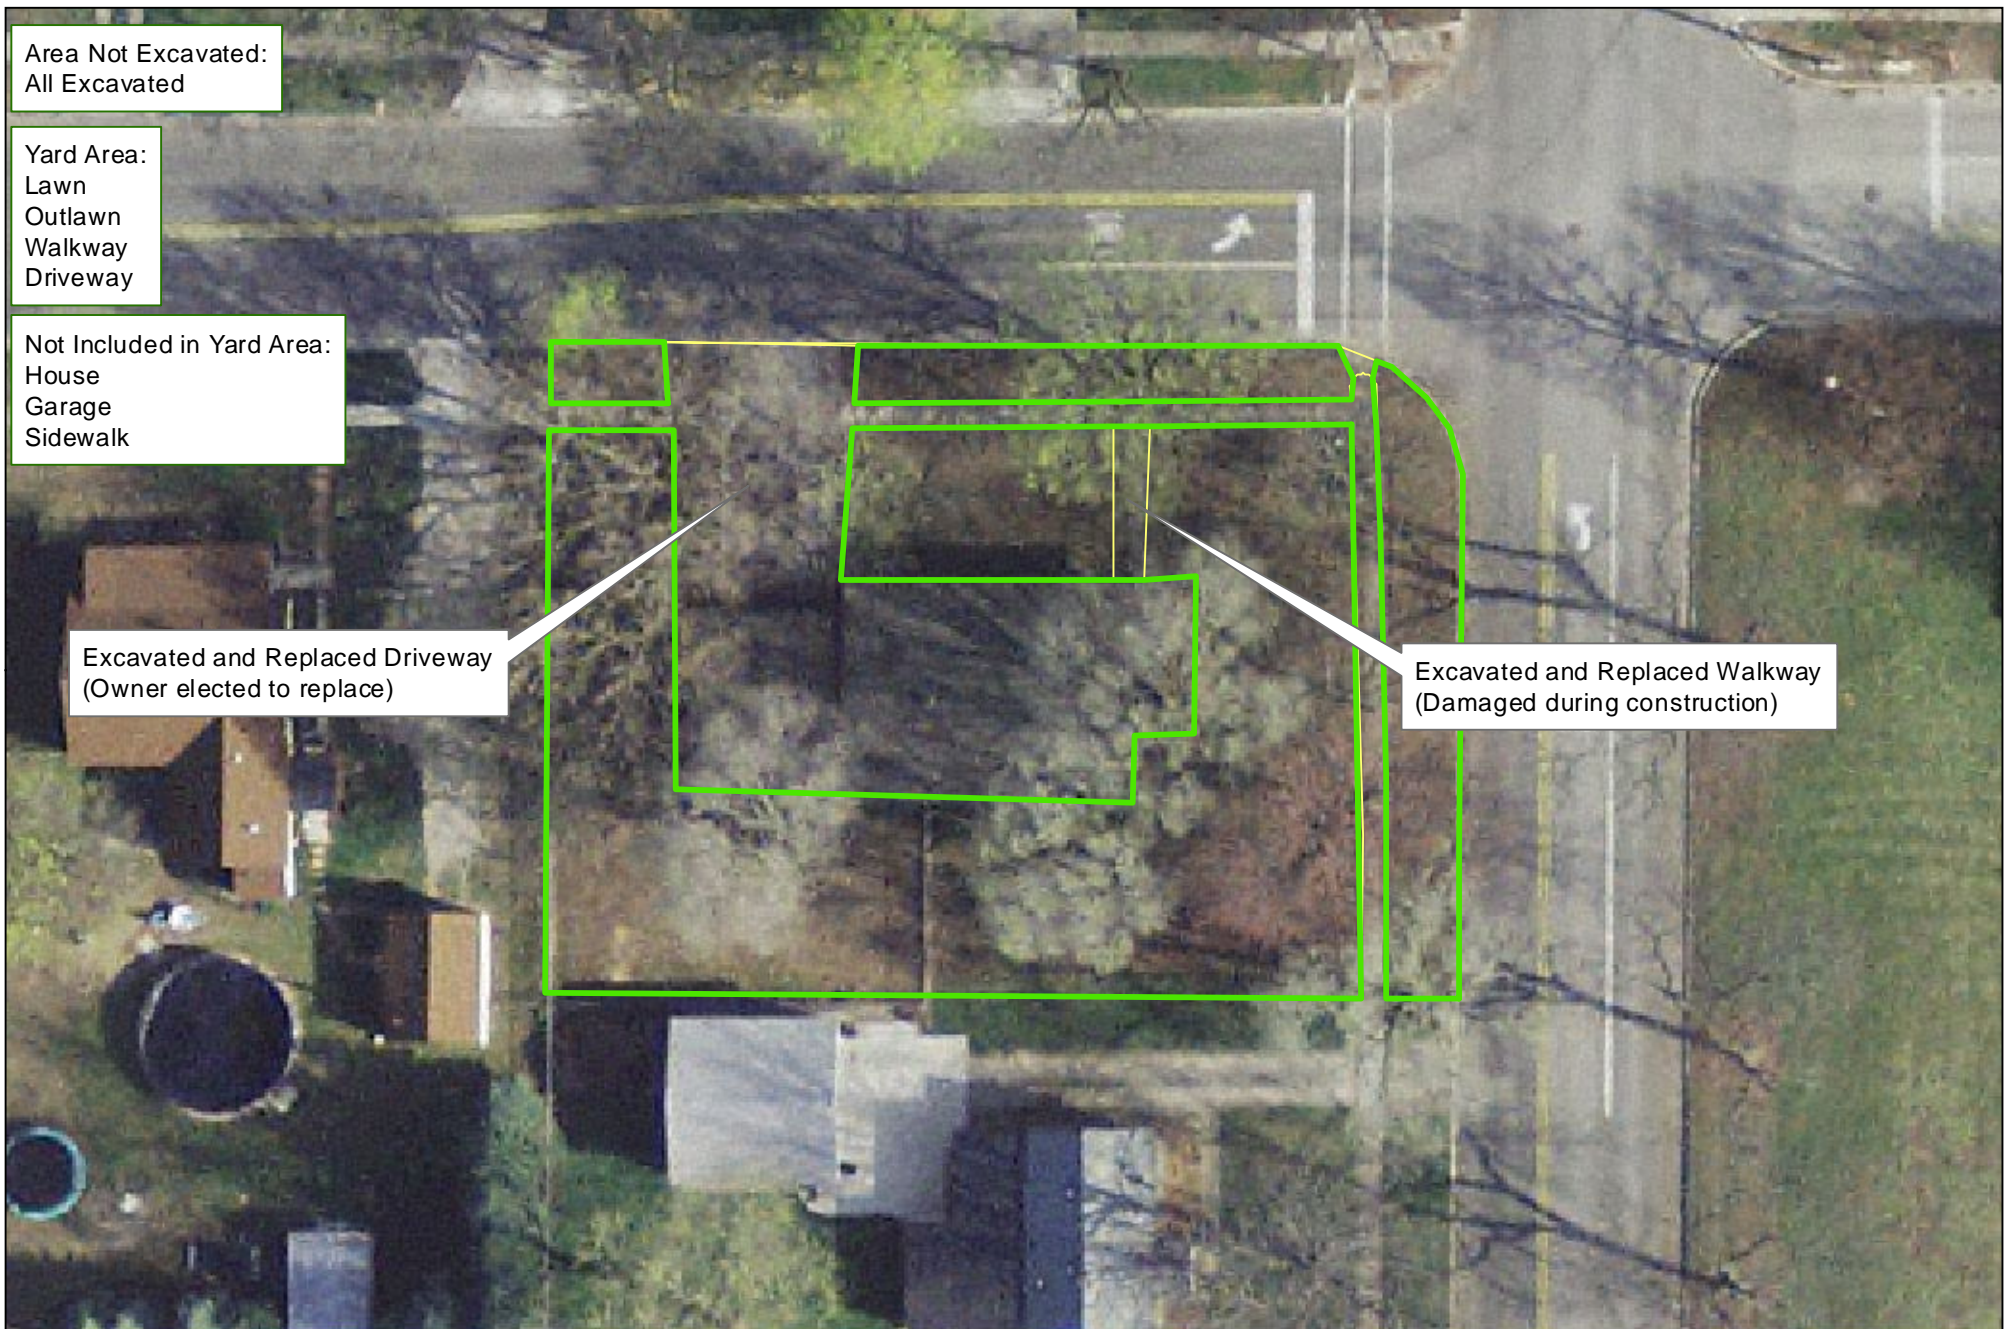
Parcel 14-15-40-062
Midland Resolution Soil Replacement

- Remediated Area
- Property

Total Yard Area:
10095 sq. ft.

Area Excavated:
10095 sq. ft.

Total Area Not Excavated:
0 sq. ft.
